FAILURE ANALYSIS CASE HISTORY

Failure analysis of superheater outlet header

Helmut Thielsch*
Robert Smoske*
Florence Cone*
Jason Husband*
Thielsch Engineering
Cranston, Rhode Island

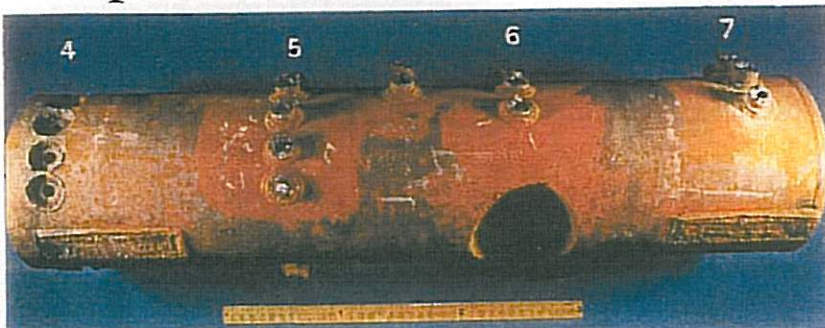
Fig. 1 — This is the 5-ft. long section cut from the west superheater outlet header in tube rows number 4 through 7. Subsegments of row 4 are referred to as A1, A2, A3, etc.

A 5-ft (1.5 m) section was cut from the west header (Fig. 1). This segment extended from tube row number 4 to tube row number 7. The visual examination confirmed that the crack that had caused the leak was located in tube row number 4. The crack essentially extended for 360 degrees around the circumference (Fig. 2), and for a large percentage of the circumference extended through the full cross-sectional wall thickness of the pipe (Fig. 3). The visual examination confirmed that the crack extended in a relatively straight manner through the cross-sectional thickness. In addition to the cracking in the ligaments, cracks had also developed in the toe of the lug weld that attached the header to a support.

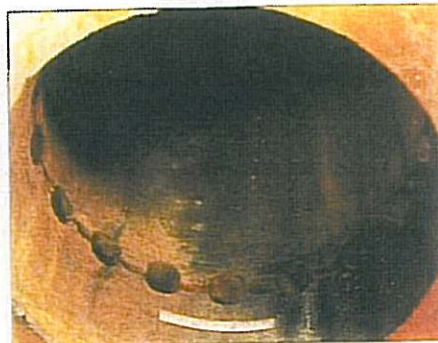
Fig. 2 — The circumferential through-wall crack in tube row number 4 is apparent along the inside surface of the header.

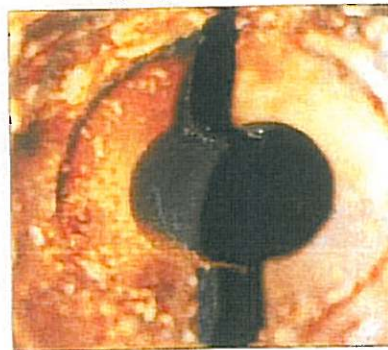
Fig. 3 — This circumferential crack extends through the wall thickness of the header.

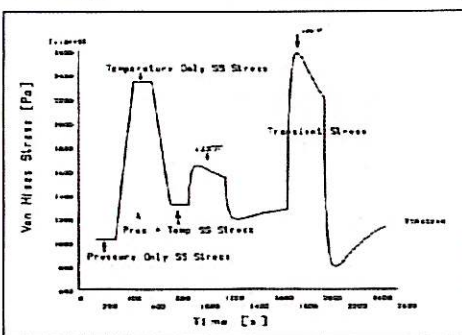
The cracking in the west superheater outlet header was caused by thermal fatigue in conjunction with hoop stresses associated with the normal operation of the unit (Fig. 4). This type of cracking initiates at the corner formed by the intersection between the bore of the tube hole and the inside diameter surface of the header. The thermal gradient at this corner is higher than at any other location in the header. In addition, the mechanical stresses at this location are consistently higher than they are at any location within the cross-sectional thickness of the header. In time, if the stresses caused by the thermal gradients and the stresses associated with mechanical loads are sufficiently high and are cyclic in nature, these combined stresses will lead to initiation and progression of fatigue cracking.

Fig. 4 — This graph illustrates the stress in the header model at point A.

header is subject to a temperature fluctuation of 25°F (14°C), the stresses at the corner of the tube hole increase by 5% or 1100 psi (7.6 MPa). If the header is subject to a temperature fluctuation of 100°F (55°C), the stresses at the corner of the tube hole increase by 77% or 16,100 psi (110 MPa). If temperature fluctuations were routine, fatigue cracking would be expected to initiate and progress through the cross-sectional thickness of the header.
