# Digester SAFETY

*Failures, failure prevention and repairs of batch and continuous digesters*

BY H. THIELSCH AND F. CONE

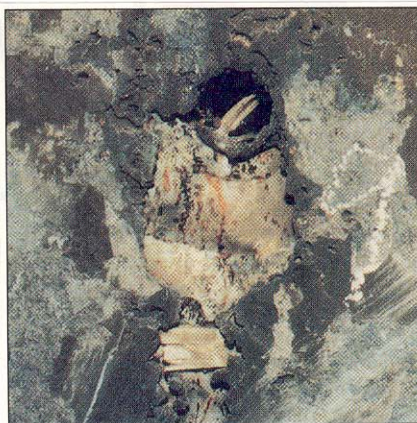
*Upper left: Corrosion grooving apparent beneath pressure tap. Upper right: Stainless steel strip lining applied over integral stainless steel cladding.*

The photo of the pressure tap's corrosion is a case in point. It was blind, i.e., it had never been used in service. Despite this, there was a groove at the 6 o'clock position of this nozzle that extended 1/8-inch to 1/4-inch into the cross-sectional thickness of the shell. This grooving is typical of that produced by run-off. It is considered likely that white liquor entered this nozzle while the digester was being filled and remained trapped during mixing. It would then seep out of the nozzle during cooking, and, at the elevated temperatures involved, would gouge the digester shell.

Blind nozzles are not the only area of concern, as similar corrosion will occur at any crevice location, such as behind retaining bars, in white liquor injection nozzles, etc.

In some cases, it is possible to modify the operation to prevent this type of corrosion from occurring. For the most part, however, it is necessary to perform repairs by welding. To insure that the repairs have some degree of longevity, it is usually advisable to complete the repairs using a welding filler material with corrosion resistance superior to that of carbon steel. Several stainless steel and Inconel alloy grades are commonly selected. The repairs should be performed in accordance with a suitable procedure and under strict quality control as improper repairs can create more problems than they solve.

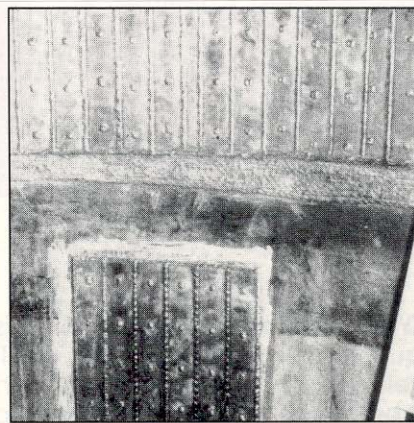
The photograph on page 54 is that of a stainless steel strip lining, and is an example of a repair gone awry. It was applied to a digester that already possessed integral (roll-bonded) stainless steel cladding. During subsequent service, the fillet welds that connected the strip lining to the cladding cracked, allowing liquor to become trapped between the strip lining and the original cladding. After a short period of time, severe stress corrosion cracking devel-

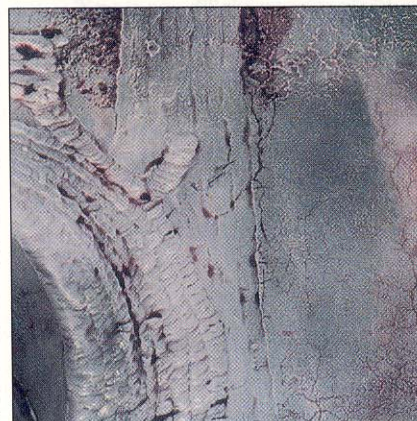
*Below left: Stainless steel cladding subject to stress corrosion cracking. Below right: Cracking observed underneath center pipe gusset plates.*

oped in the original stainless steel cladding. (The red coloring in the photos is a red liquid penetrant dye used in liquid penetrant inspections. The dye seeps into and outlines the cracks, thereby detailing every location of every crack.)

Stress corrosion cracking is due to a combination of stress, corrosive environments, and metallurgical susceptibility. In stainless steels, stress corrosion cracking generally relates to applied or residual stresses in conjunction with chloride contamination. In this instance, the fillet welds would have introduced residual stresses into the cladding.

The stress corrosion cracking in the stainless steel cladding did not extend beyond the cladding into the carbon steel shell due to the presence of a nickel bond layer at the interface. This nickel bond layer was heavily compressed, and thus provided an effective barrier to stress corrosion cracking, which will not progress in the absence of tensile stresses.

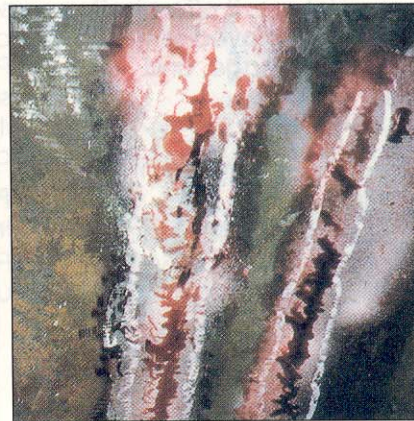
The morphology of cracking varied greatly from mill to mill. The most severe cracking—from the standpoint of digester reliability—was relatively deep, continuous cracking in the heat-affected zone of girth welds. This longitudinal cracking was occasionally found to crack 90% of the circumference of the weld to a depth of 1/2-inch or more.

Severe cracking was also observed in the toes of the fillet welds connecting the center pipe supports to the shell. (See the photo of the appearance of this cracking after the removal of the center pipe.)

Different techniques were used to address this stress corrosion cracking. Some tried grinding out the cracking and repair-welding the resultant cavities using carbon steel filler material. In general, this technique was not very successful because the repair-welding lead to higher stresses and more rapid re-cracking. Some repair-welding techniques, which incorporated a low stress buttering procedure in conjunction with a high preheat (550 degrees F), proved more satisfactory.

Others decided to overlay the affected welds with either a 300 Series stainless steel or a nickel-alloy, such as Inconel, thereby isolating the welds from the caustic environment. This approach, which was probably the most common, was not without problems. In some instances, stress corrosion cracking developed in the heat-affected zone of the carbon steel shell. (Generally, if a suitable low-stress welding procedure is used, this condition can be avoided.) In other instances, the overlay itself developed stress corrosion cracking. (That is one of the reasons that a nickel alloy is increasingly selected in preference to stainless steel.)

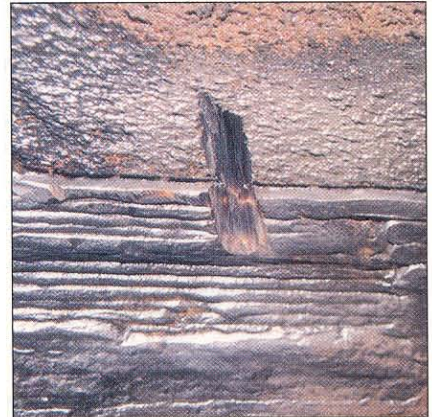
*Top: Ditching observed in toe of overlay weld.*

One of the most prevalent conditions observed in overlaid welds is corrosion ditching or "fingernailing," so-called because fingernails can slide underneath the weld overlay. Corrosion ditching can be quite severe in appearance (see photo). Generally speaking, however, it progresses for a limited distance and then becomes static. Of course, there are exceptions to every rule and mills should closely monitor this condition during annual inspections.

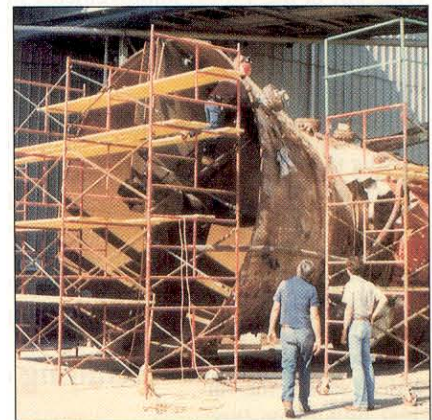
*Bottom: Catastrophic rupture of continuous digester at top transition weld.*

most dramatic is the rupture of the continuous digester at a mill in Alabama on September 26, 1980. The top 25 feet of the vessel was separated completely and was thrown against a nearby building. The failure occurred at the lower weld of the transition cone (see photo).

The failure of this digester is commonly attributed to caustic stress corrosion cracking. In this particular case, the weld that failed had not been stress relieved and, therefore, contained fairly significant stresses. These residual stresses, in conjunction with the caustic black liquor, were sufficient to result in the gradual initiation and propagation of stress corrosion cracking.
