CORROSION 91

ACCELERATED TUBE METAL WASTAGE IN MUNICIPAL SOLID WASTE FIRED FURNACES

W.G. Schuetzenduebel, I.E. Johnson and C.W. Clemons
Blount Energy Resource Corporation
4520 Executive Park Drive
Montgomery, AL 36195

H. Thielsch
Thielsch Engineering Associates, Inc.
195 Frances Avenue
Cranston, Rhode Island 02910

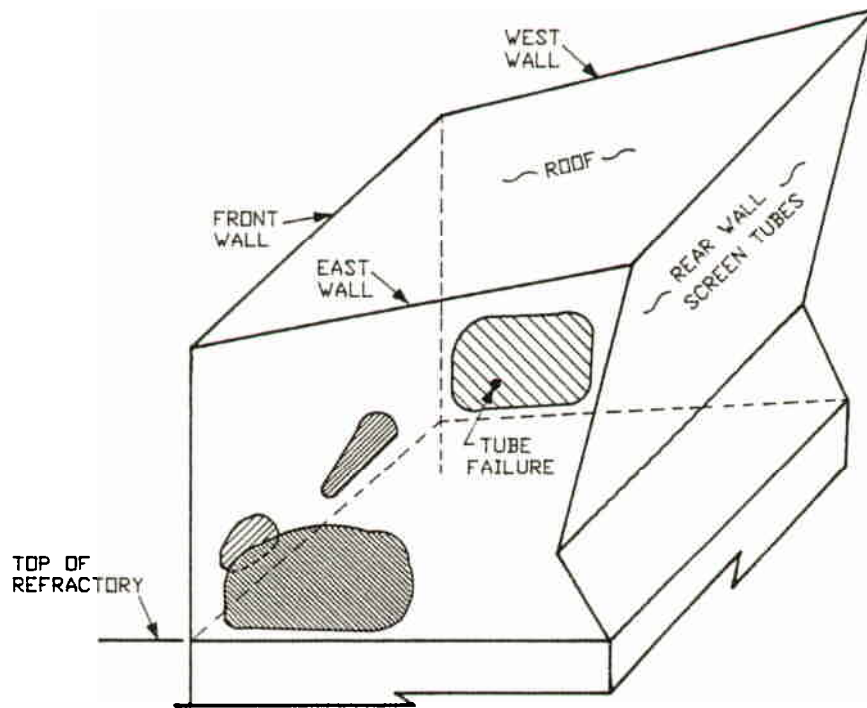
Figure 2. Furnace Gas Passage Schematic.

- FRONT WALL GENERAL TUBE THINNING AREA
-

- WEST WALL GENERAL TUBE THINNING AREA
-

- EAST WALL GENERAL TUBE THINNING AREA

The immediate task at hand following the tube failure in the No. 2 Unit was to affect repairs and bring the unit back on line. To determine the extent of the problem, a detailed ultrasonic wall thickness survey was performed over the three waterwall sections in the furnace. Readings were taken commencing at the top of the refractory lined zone and extending to a distance of 6' - 6" above the refractory. It was concluded from these data that tube wall thinning was occurring on three furnace walls with severest thinning on the west wall where the tube rupture occurred (see Figure 2).

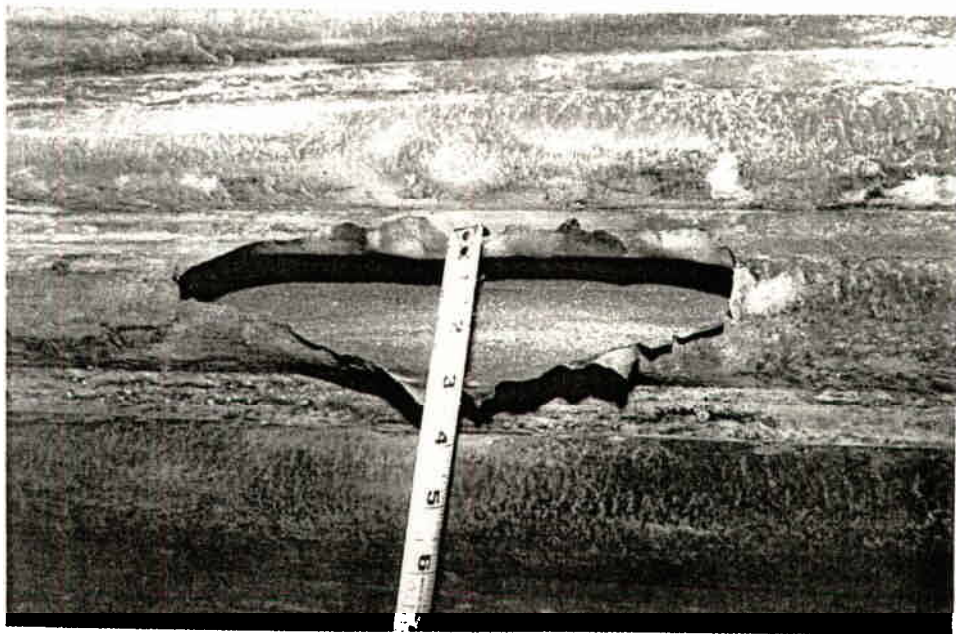
The failure of this tube in the No. 2 boiler was totally unexpected. Only 18 days prior to the failure, the No. 1 boiler had been given a thorough inspection and cleaning during a routine annual shutdown. The inspection included a survey of tube wall thicknesses using a KB ultrasonic thickness gauge. Measurements were taken throughout the furnace/boiler and compared with baseline readings taken shortly after initial start-up. Results showed practically no reduction in tube wall thickness. Following the tube failure in the No. 2 boiler, the No. 1 boiler was again subjected to a detailed tube wall thickness survey. Again, wall thickness deterioration was not apparent. How could it be that one boiler could experience metal wastage and tube failure while an identical boiler (same tube configuration, refractory, air supply and fuel) operating in parallel under similar operating conditions showed little or no signs of corrosion?

Figure 3. Photograph of Failed Tube.

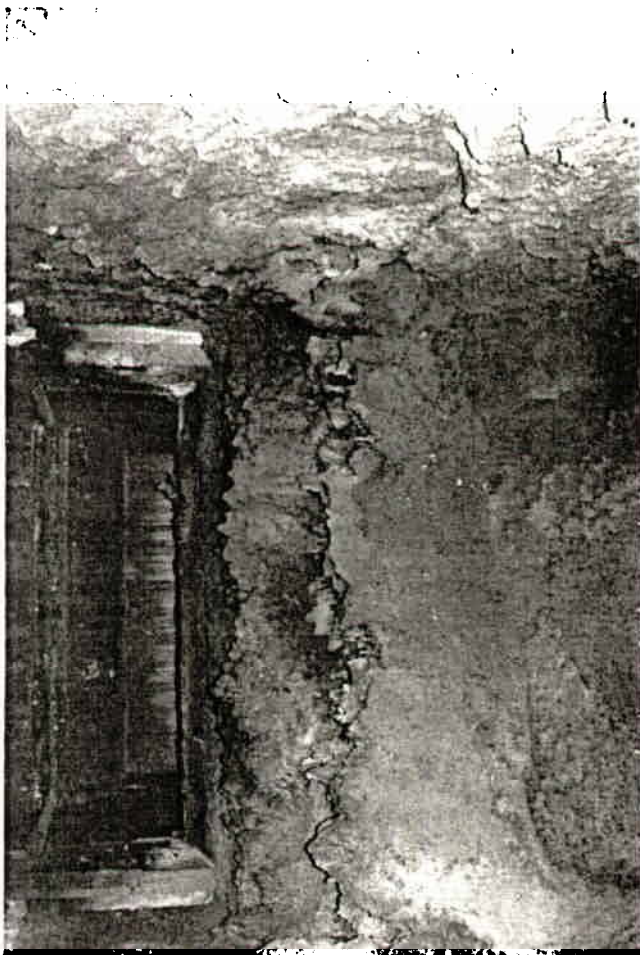
Following the tube rupture, an internal inspection of both boilers was conducted. These inspections revealed a difference in slagging characteristics between the two units. Specifically, a large slag shelf was observed over the secondary air nozzles in the front wall of Unit No. 2, extending to as much as two feet into the furnace. Figure No. 4 is a photograph of this slag build-up. Also, differences in slagging of screen tubes and convection surfaces were observed between the two units. Unit No. 1 had the most severe slagging in the front sections with screen tubes plugged evenly over their length and slagging decreasing to virtually none in the economizer. Unit No. 2 had completely plugged screen tubes for the upper ten feet. Figures 5 and 6 are photographs of the slagging condition on the screen tubes and evaporator section, respectively, of Unit No. 2.

The most probable cause of the localized reducing atmosphere in Unit No. 2 was the build-up of a large slag shelf over the secondary air nozzles which restricted air flow and prevented adequate mixing of combustion products and air.

Figure. 4. Slag Build-up Over Secondary Air Nozzles.

- More frequent observation of firing conditions on the grate to detect smoldering fires, overloaded grate sections, incomplete combustion, grate section failures, air problems etc.
- Frequent inspections to detect slagging, particularly in the areas surrounding the secondary air nozzles to assure unobstructed full air flow and to record progression of slag buildup.
- Increased surveillance of the condition of boiler tube rappers and components and a requirement to make immediate repairs to defective parts.

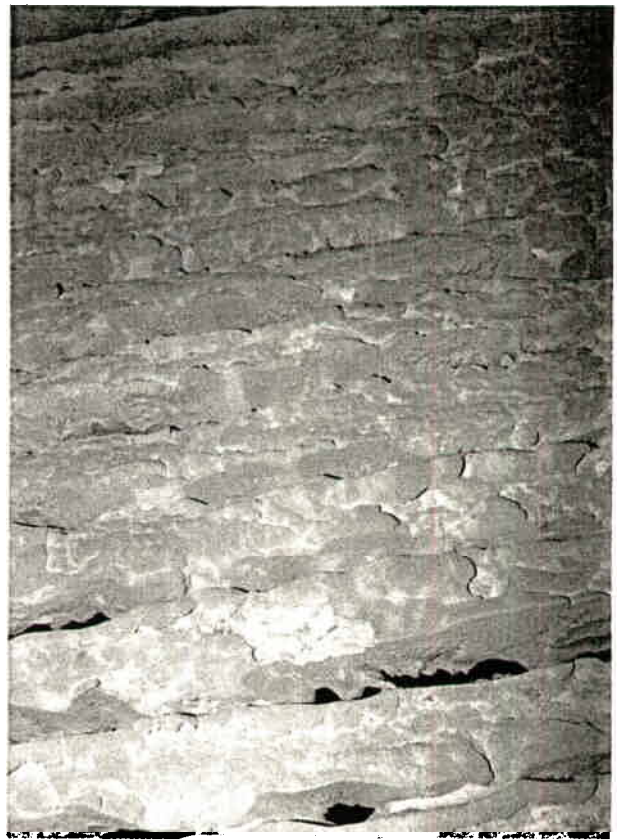
Figure 5. Screen Tube Slagging Condition.

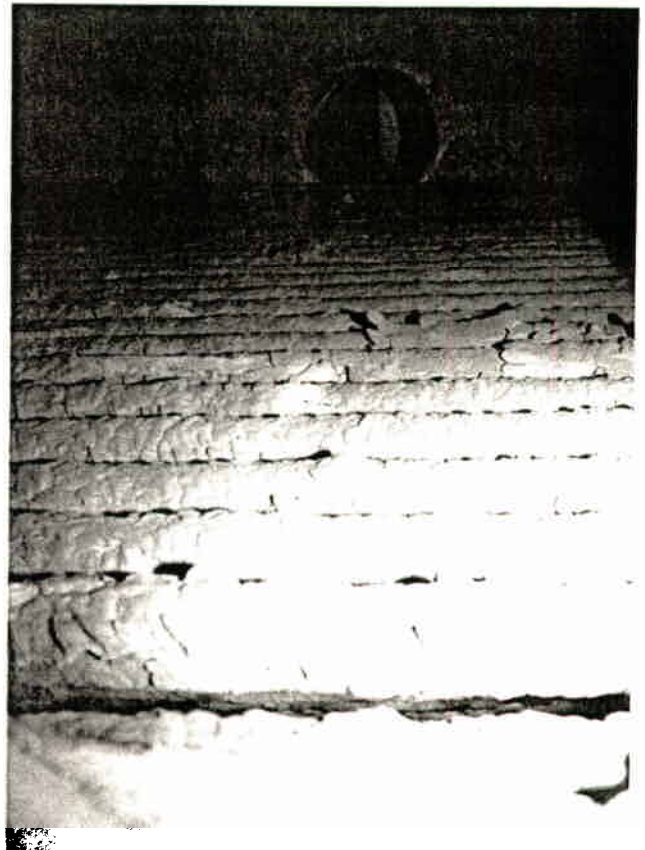
Figure 6. Slagging Condition of Evaporation bundle Tubes.

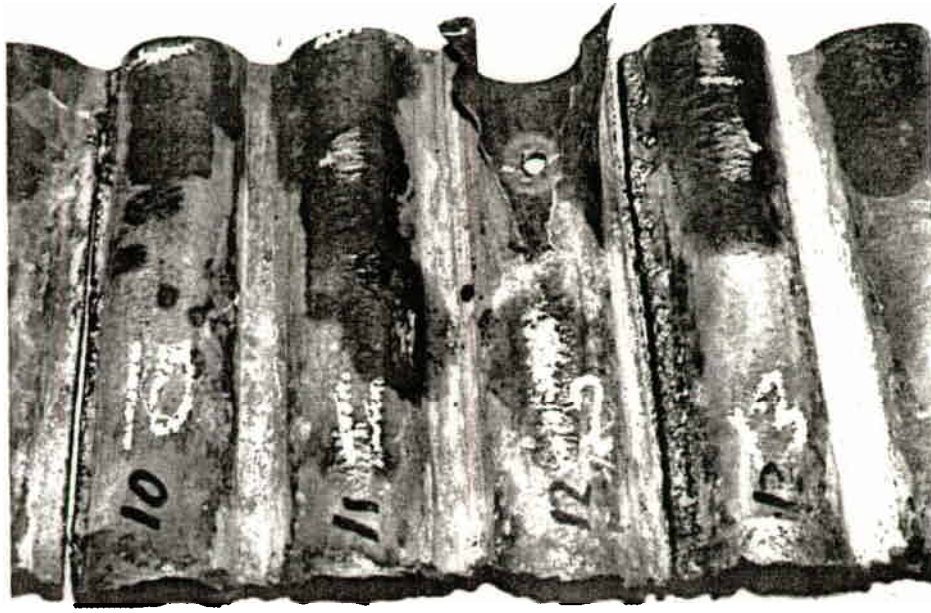
Tube samples from the failed area of the front wall were submitted to Thielsch Engineering Associates, Inc. for examination and testing. Figure 7 is a photograph of the tube samples submitted which included the failed tube denoted as tube No. 12.

Visual examination showed severe wall thinning in the failed tube. In addition, the fireside of the failed tube and other adjacent tubes had a very rough texture, typical of fireside corrosion.

Figure 7. Overall View of Tube Panel Examined.

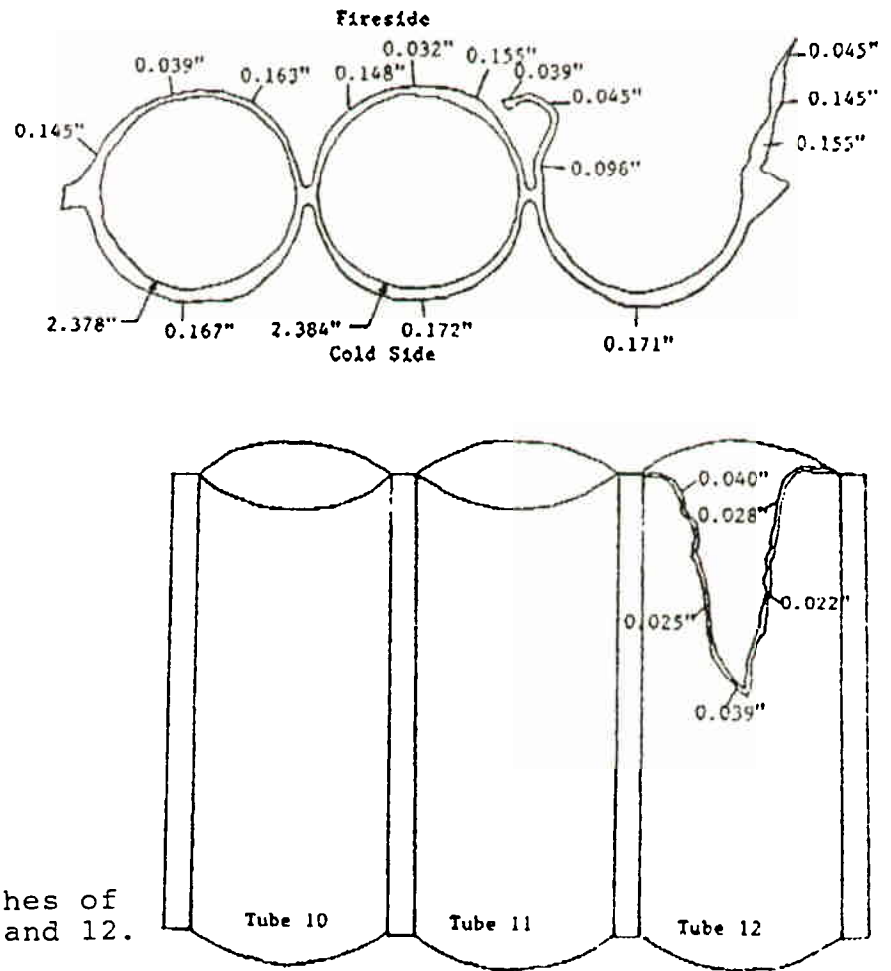
A dimensional sketch was prepared to document the wall thinning in the failed tube and in the adjacent tubes. Results are shown in Figure 8. It was noted that the loss of wall thickness in all tubes examined had occurred from the outside diameter of the tubes and was most severe along the fireside crown. The wall thickness at the failure location was 0.022 inches, representing a reduction of 87% from the original wall thickness as recorded along the cold side of the tube.

Figure 8. Dimensional Sketches of Tubes Nos. 10, 11 and 12.

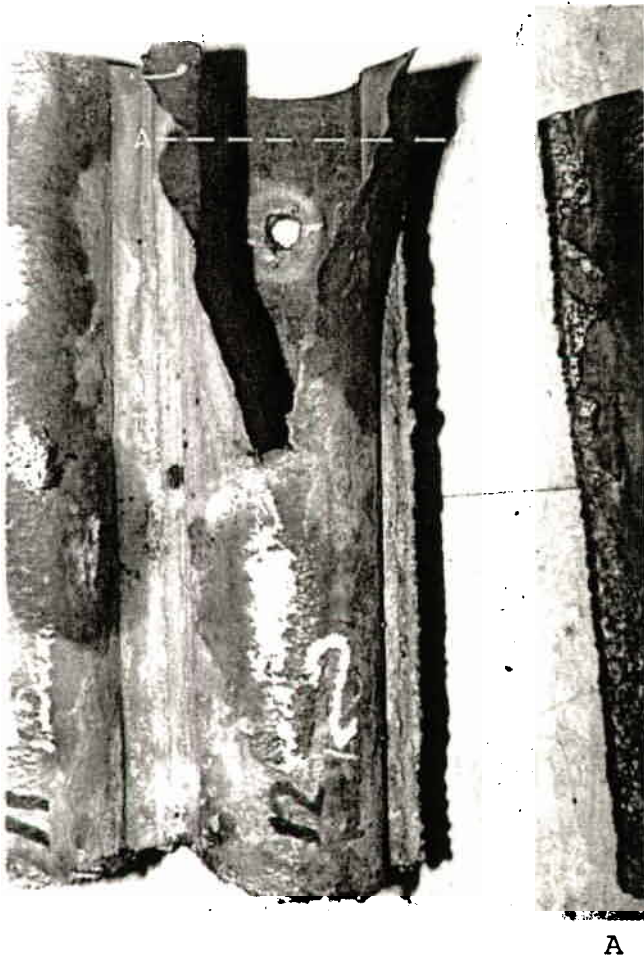
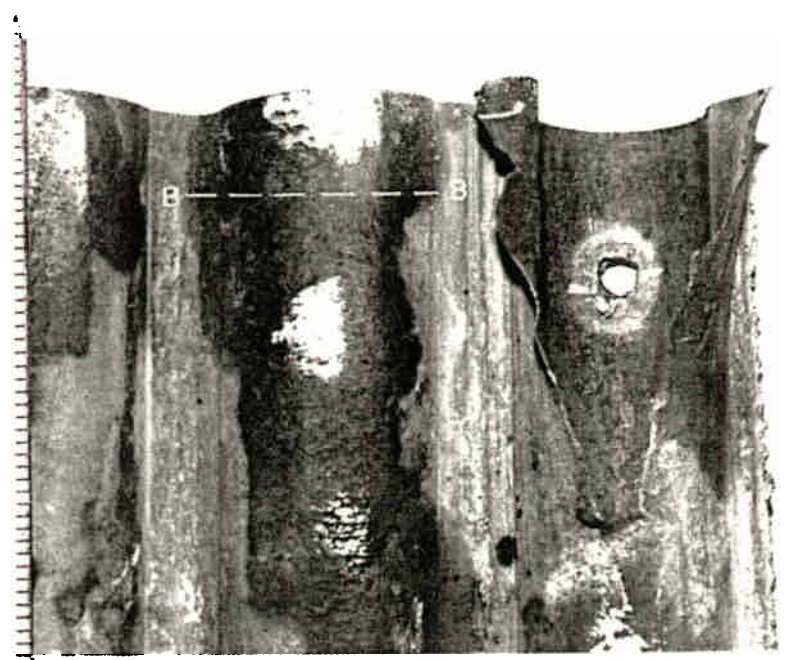
Cross Section "A-A." Tube No. 12 was cross-sectioned through the leak location at "A-A", as indicated in Figure 9. The subsegments removed are shown subsequent to metallographic preparation at a magnification of 1X in Figure 10. Rockwell "B" hardness determinations were made at the locations shown. Corresponding Brinell hardness numbers, provided in (), ranged from 89 BHN to 98 BHN. This extrapolates to a tensile strength of 45,000 psi. This is slightly low for tubing produced in accordance with ASME Specification SA-178, Grade A, but is still considered acceptable.

Figure 9. Close-up Views of Failure Locations (1/2X).

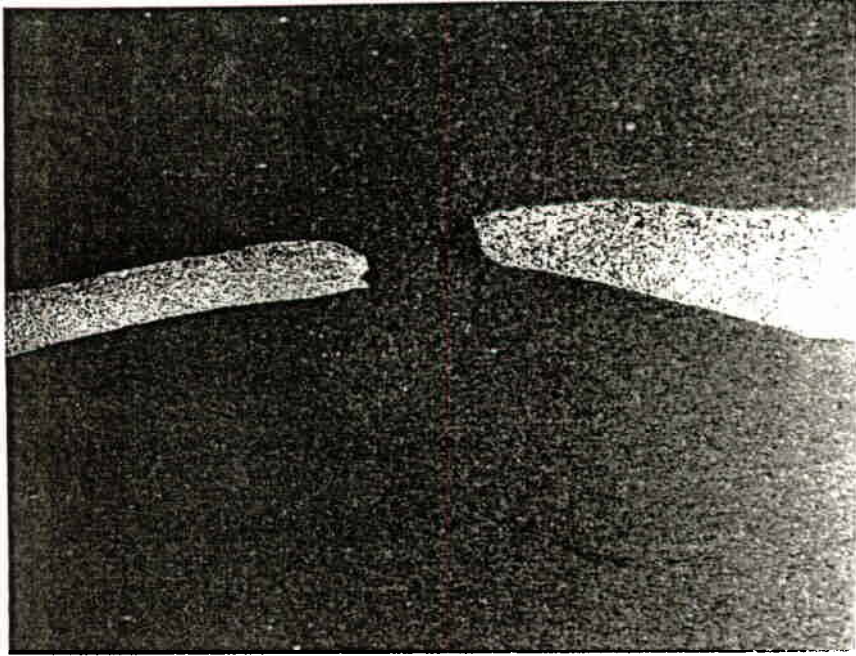
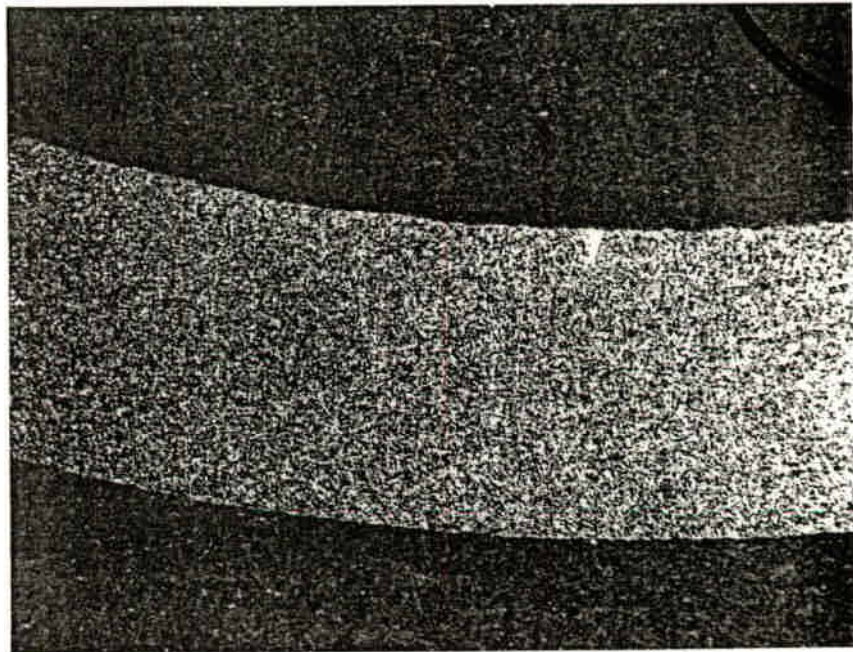
These locations, identified as "A₂" to "A₅" are indicated on the photomicrographs (magnification 10X) supplied in Figure 11.

Figure 11. Photomicrograph of Cross Section "A-A".

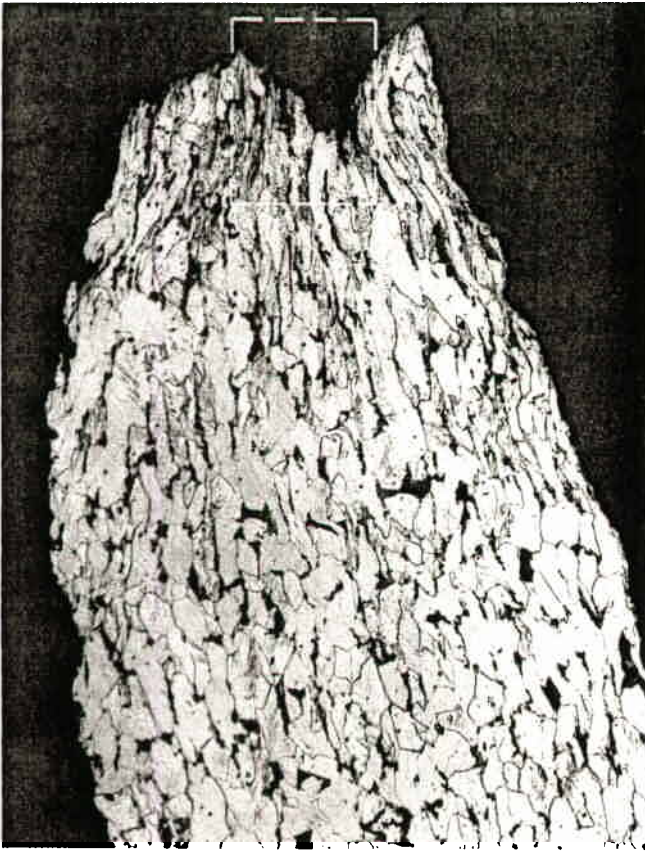
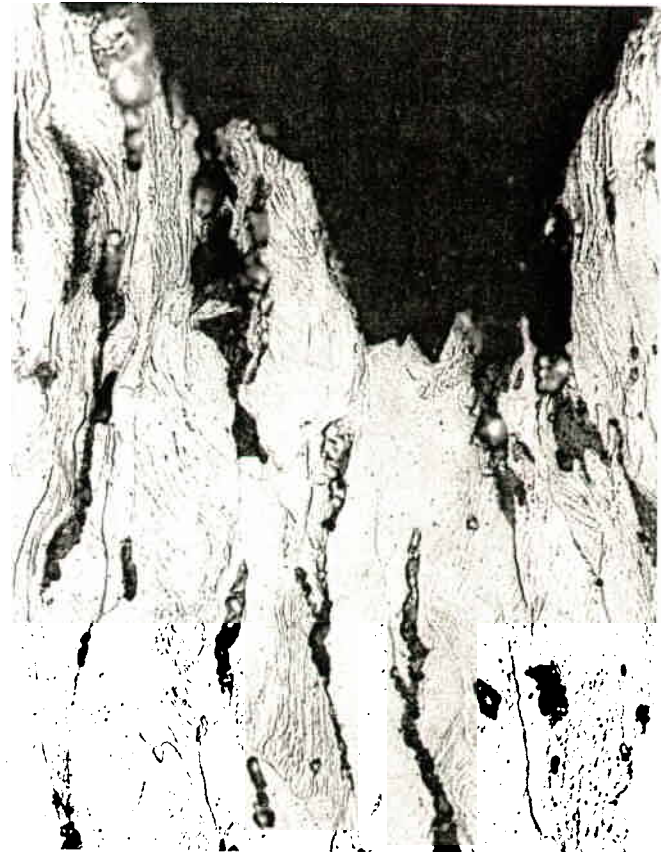
Area "A₂", located at the fracture surface, is shown at magnifications of 100X and 500X in Figure 12. The microstructure at this location consisted of ferrite and lamellar pearlite. The grains of each constituent showed straining and also elongation as a result of the rupture.

Figure 12. Microstructure At "A₂" (100X) (500X).

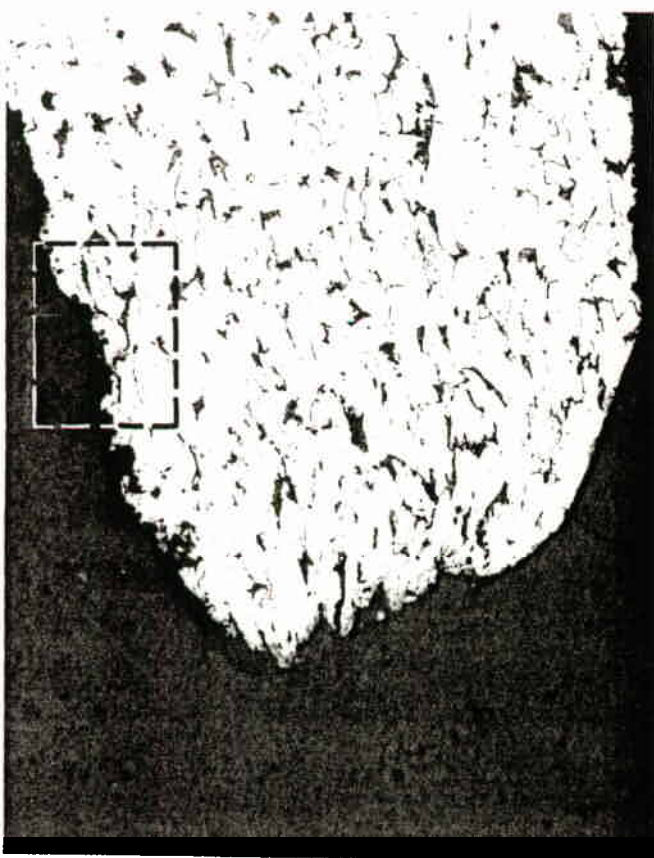
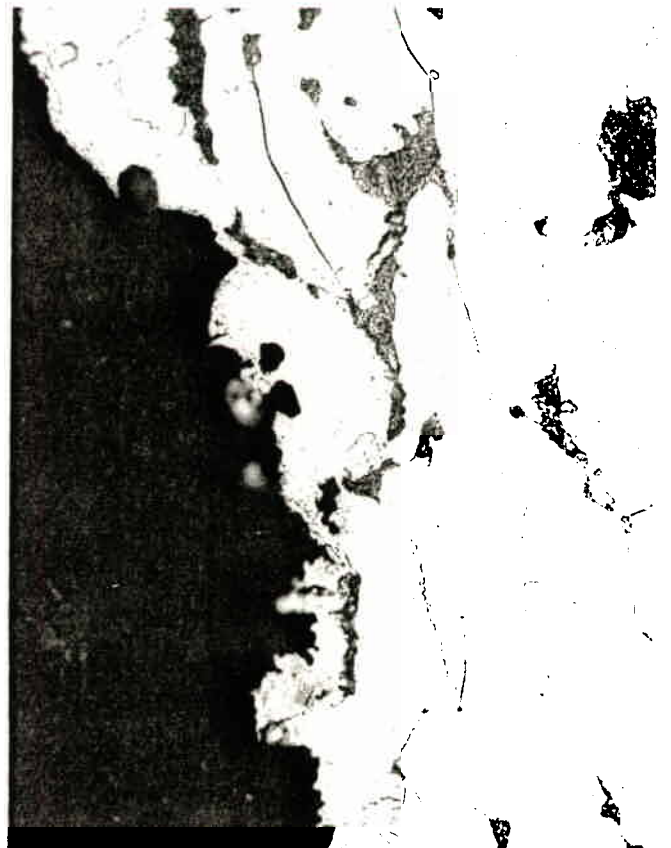
Area "A₃", located at the mating fracture surface, is shown in Figure 13. Intergranular attack was evident along the outside surface. This is typical of a corrosion associated phenomenon. The microstructure was similar, comprised of ferrite and lamellar pearlite. The presence of lamellar pearlite is indicative that this tube was not subject to overheating.

Figure 13. Microstructure At "A₃" (100X) (500X)

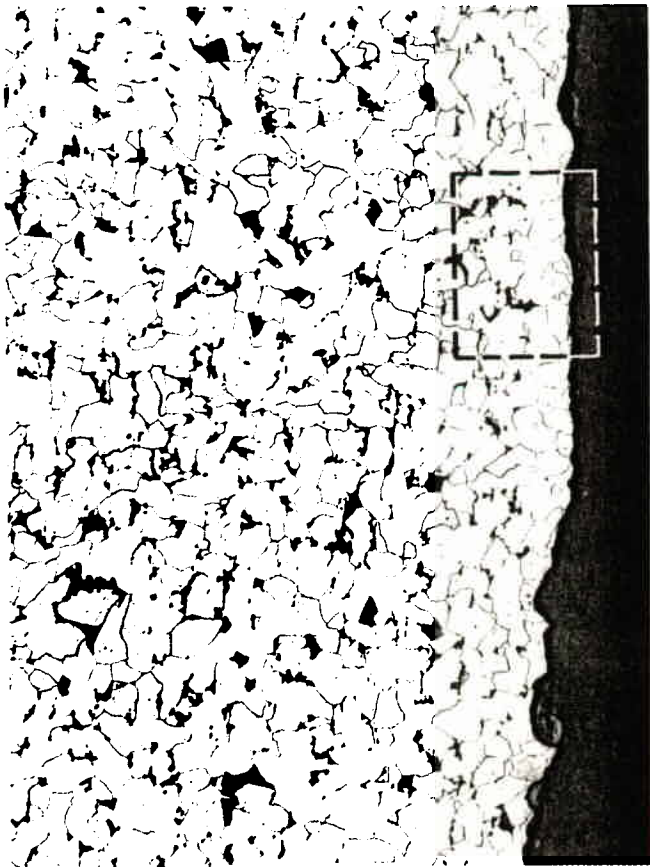
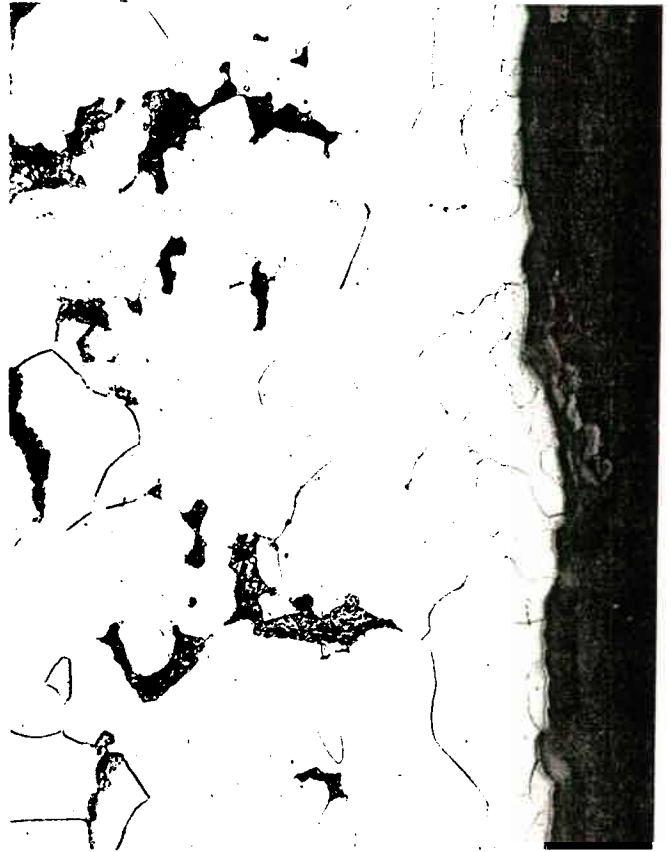
Areas "A₄" and "A₅", located along the outside and inside diameter surfaces of the 180° subsegment, are shown in Figures 14 and 15 respectively. The

microstructure was typical, comprised of ferrite and lamellar pearlite. There was little or no scale formation. This is also indicative that the tube had not been subject to overheating.

Figure 14. Microstructure At "A₄" (100X)
(500X).

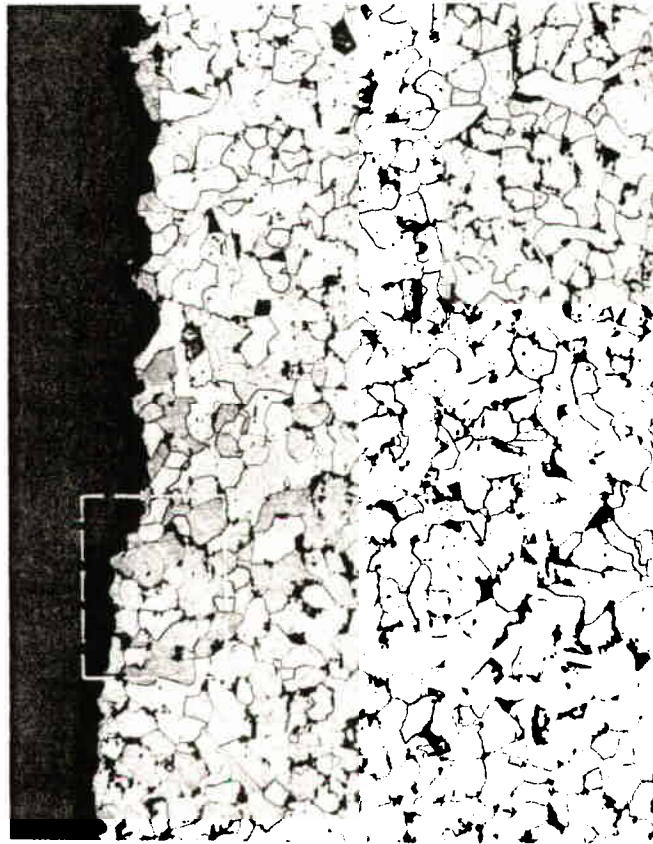
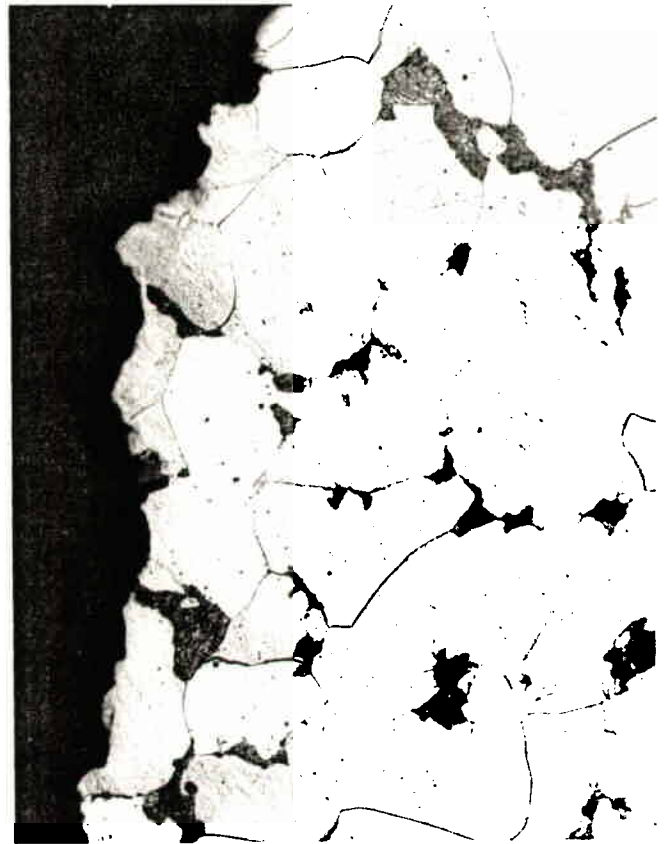
Figure 15. Microstructure At "A₅" (100X)
(500X).

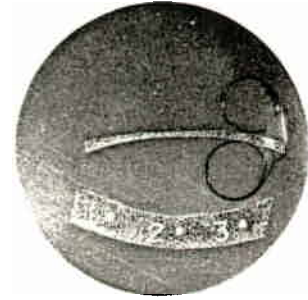
Cross Section "B-B." Cross section "B-B" was cut through tube No. 11 at the elevation corresponding to the leak location in Tube 12 (reference Figure 9). It is shown subsequent to metallographic preparation at a magnification of 1X in Figure 16. Rockwell "B" hardness determinations were made at the locations shown.

Brinell hardness numbers are provided in (). The hardness values recorded ranged from 98 BHN to 99 BHN and are considered acceptable.

Figure 16. Overall View of Cross Section "B-B".

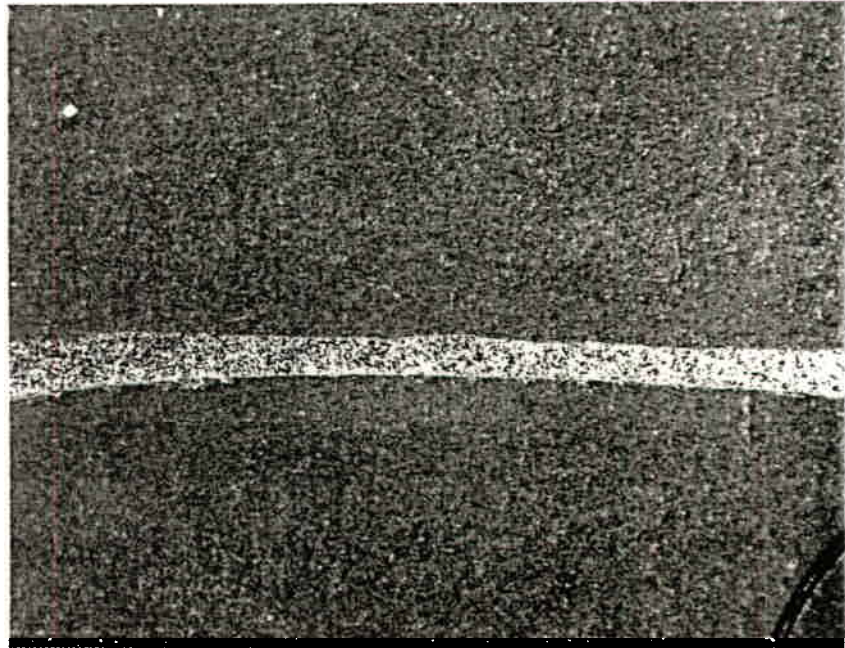
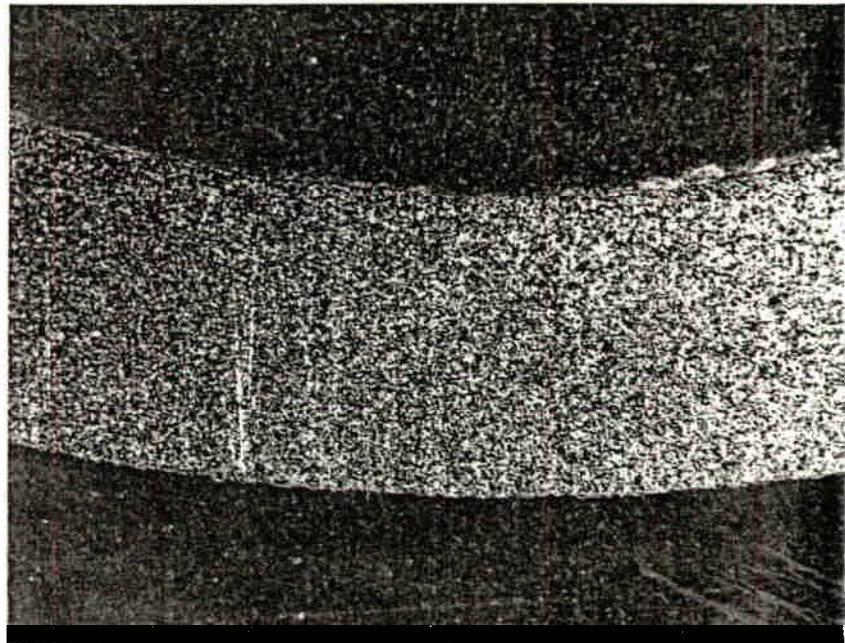
Photomicrographs of the subsegments, provided in Figure 17, document the severe reduction in wall thickness at the 0° side. The minimum wall thickness measured 0.020". This represents 12.5% of the original wall thickness (0.160") recorded on the 180° side, ie., an 87.5% loss of the original wall thickness.

Figure 17. Photomicrograph Of Cross Section "B-B" (10X).

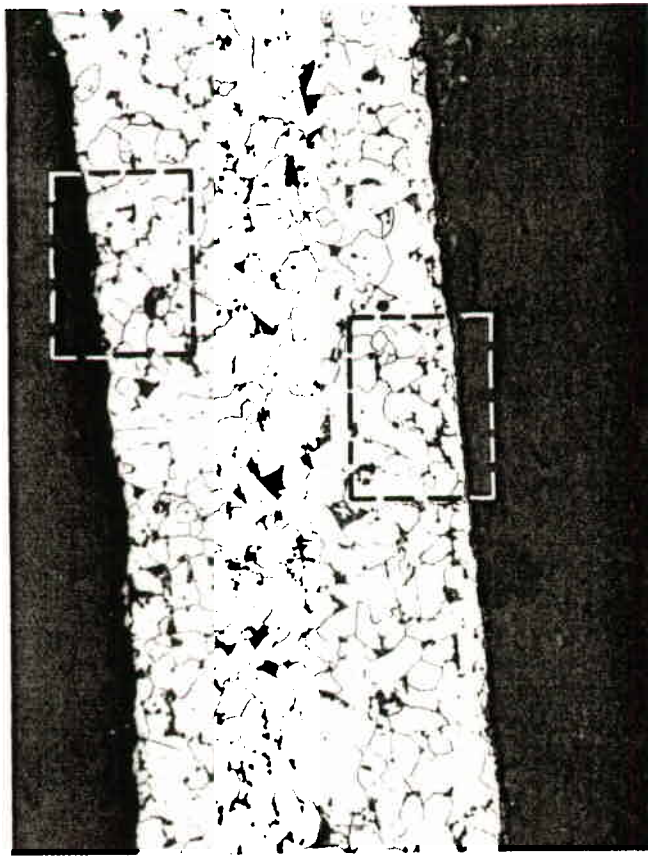
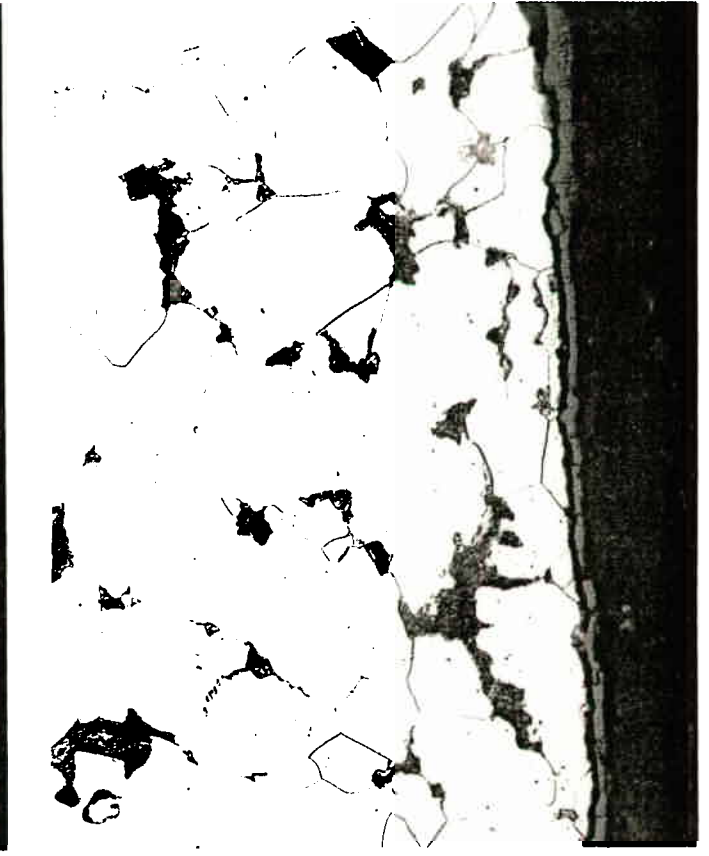
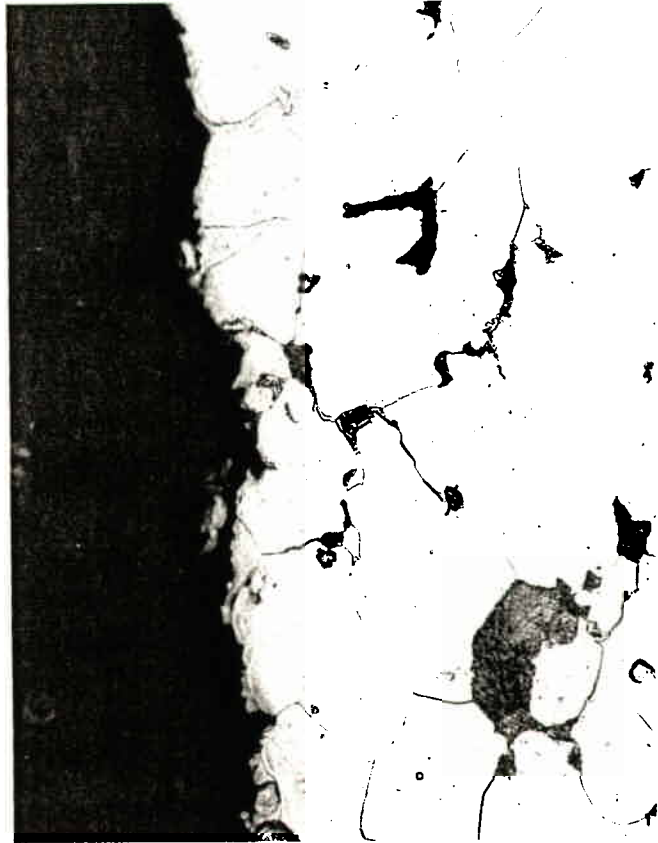
The microstructure observed in these subsegments is documented at higher magnifications in Figures 18 through 20. It was similar to that observed previously, comprised entirely of ferrite and lamellar pearlite. There was minimal scale formation observed, again confirming that these tubes were not subject to overheating.

Figure 18. Microstructure At "B₂" (100X)
(500X).

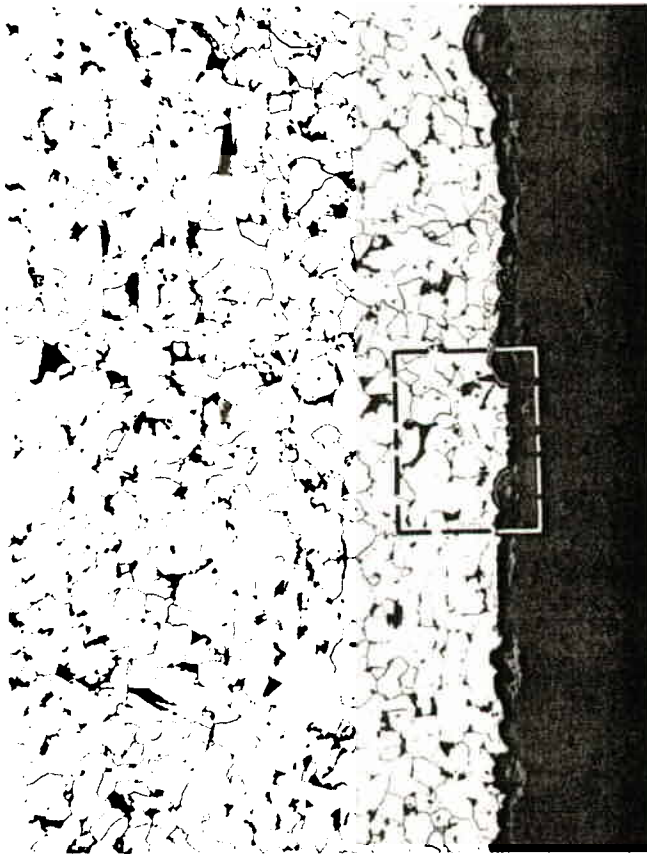
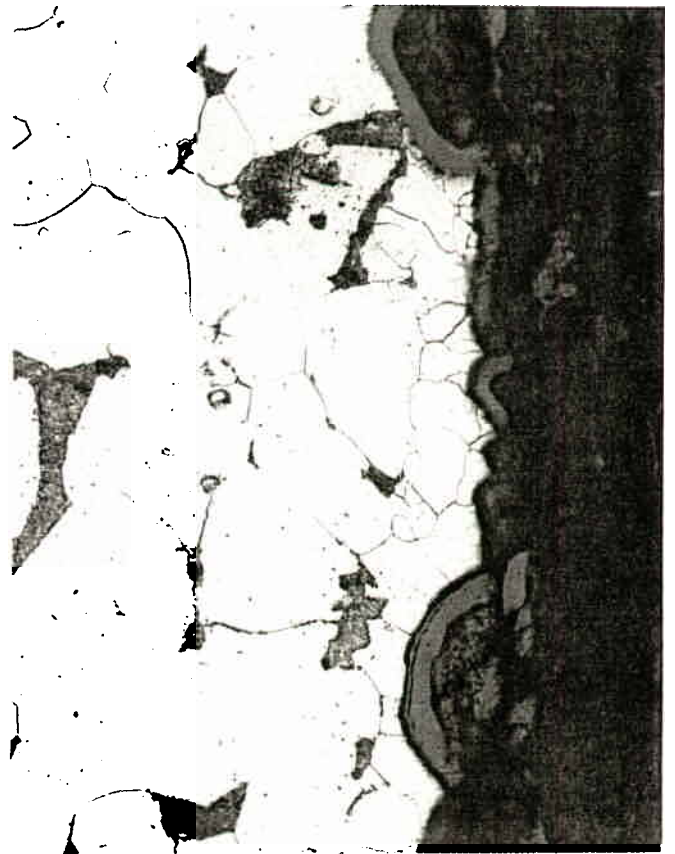
Figure 19. Microstructure At "B₃" (100X)
(500X).

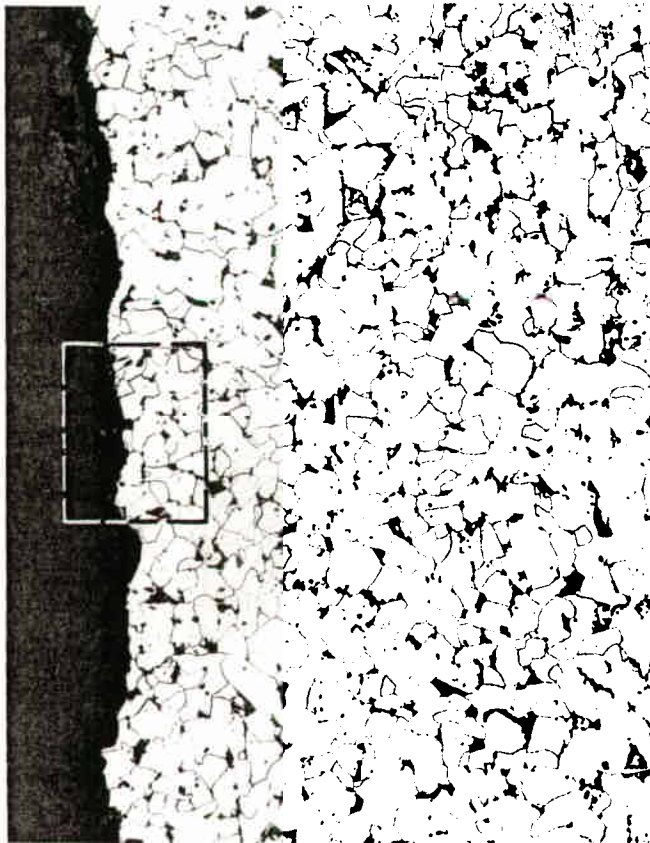
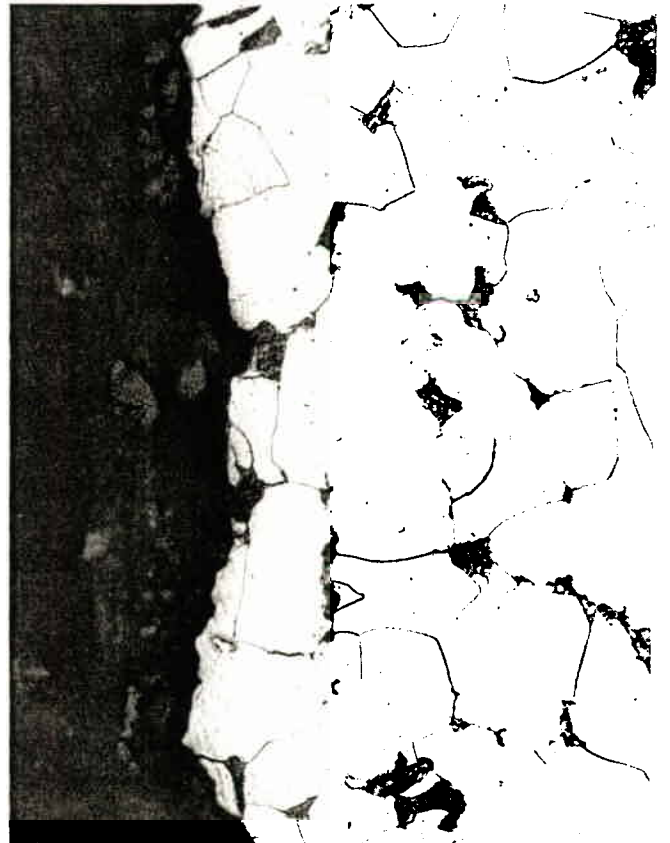
Figure 20. Microstructure At "B₄" (100X)
(500X).

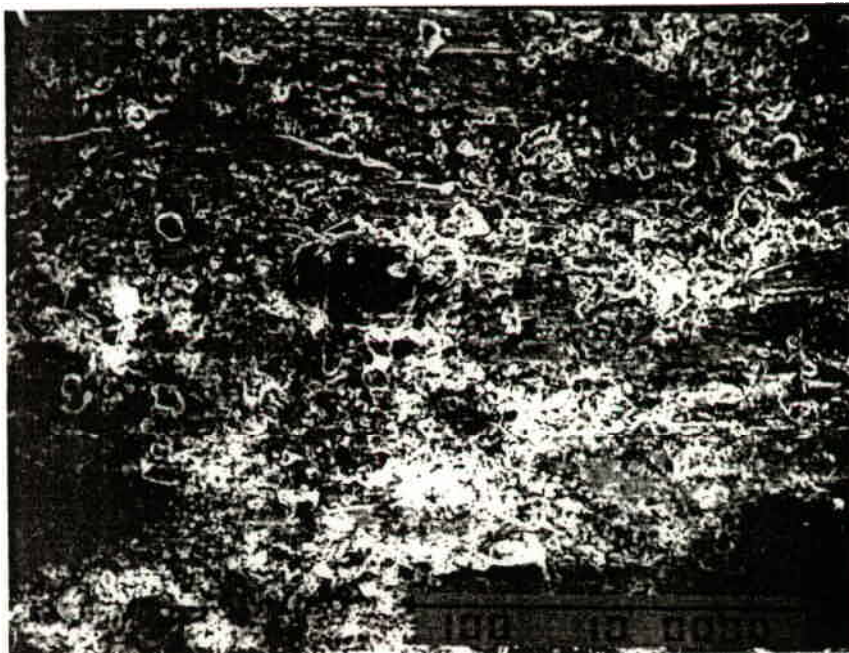
Microscopy (SEM) in conjunction with Energy Dispersive Spectroscopy (EDS). A scanning electron micrograph at location "C" (reference Figure 9) is provided in Figure 21. An energy dispersive spectral plot recorded at this same location is provided in Figure 22. Sulfur and chlorine peaks were observed. In addition, trace quantities of potassium and zinc were noted. Under the operating conditions involved, all four of these elements can cause extensive problems, particularly the presence of significant quantities of sulfur and chlorine.

Figure 21. Scanning Electron Micrograph (SEM) At Location "C".

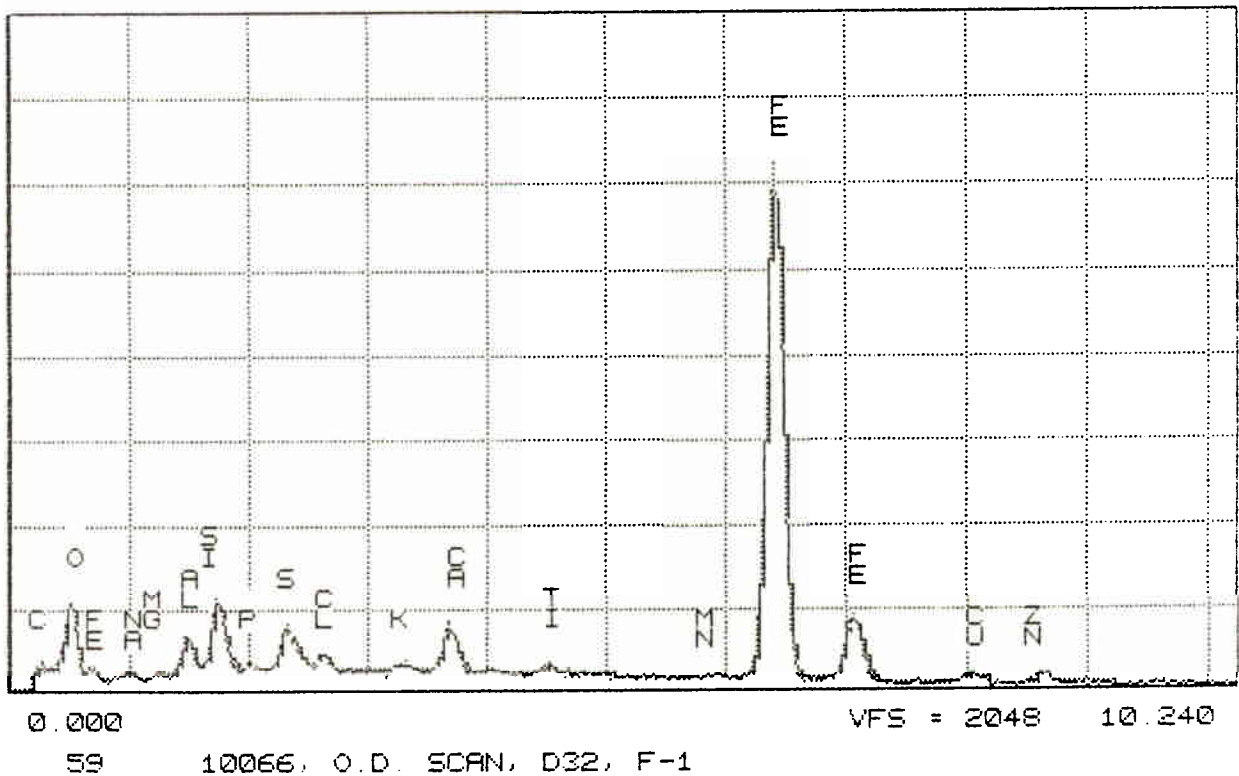
Figure. 22. Energy Dispersive Spectral (EDS) Plot At Location "C".
