Casing repair adds years of service to vintage turbine

Many old fossil-fired units must operate on an as-needed basis. But cracking is inevitable. Here, rehabilitation of a turbine casing is described that required 25% of the downtime and less than 7% of the cost of replacing it

By N Knarr and H Thielsch, Thielsch Engineering Associates Inc, and D Schneider, Ohio Edison Co

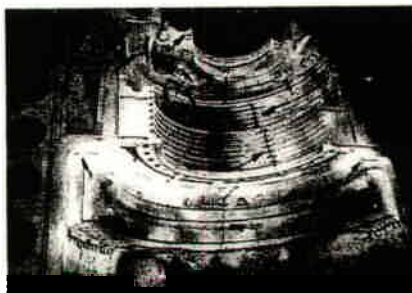
Fig 1 illustrates the various crack locations discovered following a liquid-pene-

trant examination. More sophisticated and more expensive evaluation techniques—such as finite-element or stress analyses—were not considered necessary for this repair.

1. Arrows highlight areas selected for crack removal and repair

Crack removal was accomplished with either arc-air gouging or grinding, depending on the extent of cracking and its location. In areas where the mechanical stitching had not held, all stitches plus the cracks were removed. This increased the amount

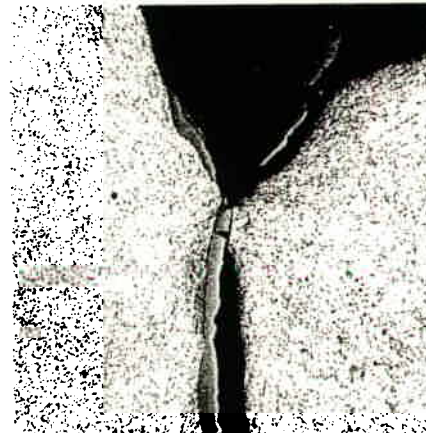
Microstructural analysis (Fig 2) and scale-thickness measurements of a sample removed from a crack in the upper shell suggested the crack began 90,000 hours before the through-wall cracking—and steam leakage—was documented. The analysis also confirmed that cracking was caused by thermal fatigue associated with cyclic operation and mechanical stresses associated with cross-sections of uneven thickness. The latter condition resulted when the partition was removed.

2. Microstructure analysis indicates when crack was initiated

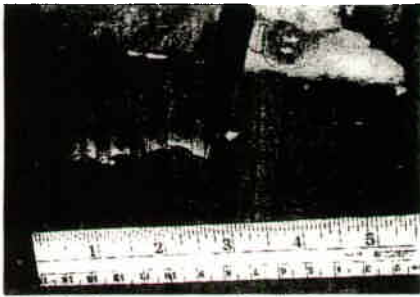
Unique to this unit, however, was a design modification which occurred prior to 1960. For unspecified reasons, one of the partitions in the nozzle chamber area had been removed. The weakened condition contributed to the progression of cracking across the high-pressure and low-pressure dummy seal areas.

3. Distortion is apparent in gland area where steam leakage occurred

so the additional service life expected of the repair program was considered achievable. Modifications to the nozzle-block area (Fig 3) were part of the repair program.

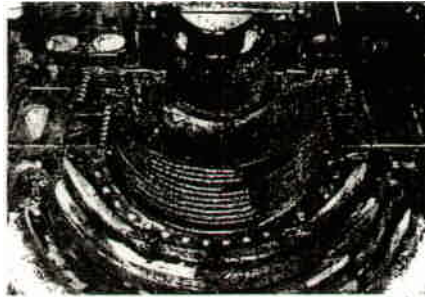
4. Lower casing is shown after repair and addition of new partition in steam inlet area

Throughout the repair process (Fig 4), dimensional measurements were made to monitor axial and radial growth. Adjustments to the heat-treating and welding procedures were made accordingly.

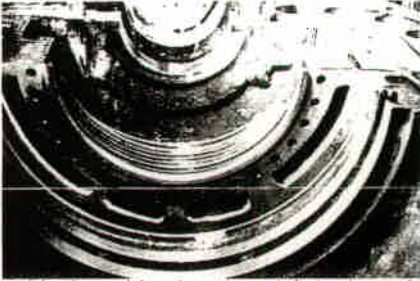
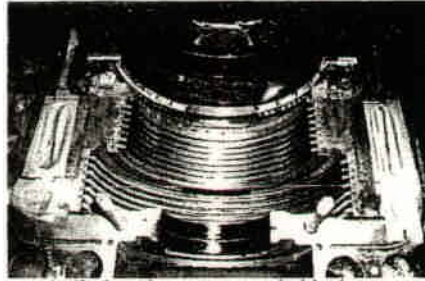
5. Final machined surface, left, is shown for lower half of casing; new nozzle blocks are installed, right

Machining was done with both halves bolted together (Fig 5). The unit was reassembled and returned to service.
