CAUSES AND RESOLUTION OF THROUGH-WALL CRACKING IN A COLD REHEAT PIPING SYSTEM

William Thurley, P.E., Senior Mechanical Engineer
Thielsch Engineering, Inc.

Anthony Carrino, Mechanical Maintenance Supervisor
Illinois Power Company

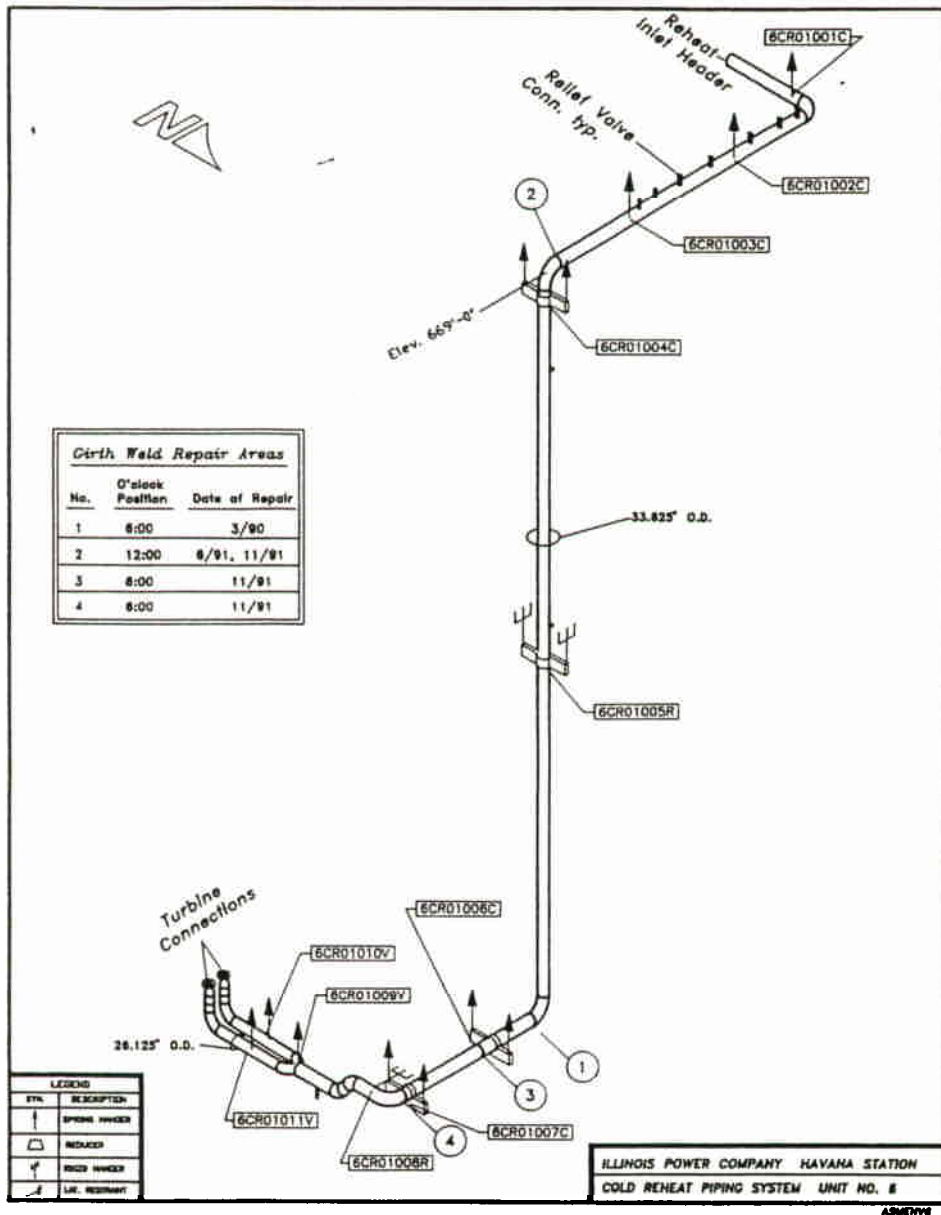
FIG. 1. COLD REHEAT PIPING SYSTEM AFTER HANGER MODIFICATIONS

The first leak occurred in the Cold Reheat piping system in March of 1990. It developed at the 6:00 o'clock position of the girth weld immediately upstream of the riser. This is denoted as location 1 on the system isometric sketch, Fig. 1.

On June 27, 1991, a second through-wall leak occurred in the Cold Reheat piping system, denoted as location 2 on the system isometric sketch. The failure occurred in the upper horizontal lead at the 12:00 o'clock position of the first circumferential weld downstream of the riser. The cracking at this location had initiated on the inside diameter of the pipe. The crack length along the inside diameter of the pipe was approximately 26 inches. Like the 1990 failure, the crack was located on the side of the pipe in greatest tension due to bending stresses.

At the beginning of the November, 1991 outage, a third through-wall crack was discovered. Water leakage was apparent while the lower portion of the system was under hydrostatic pressure. Failure location No. 3, as indicated on

To lower system operating stresses, it was recommended that a pair of constant support hangers be installed to replace rigid hanger 6CR01007R. The constant support hangers would allow for the desired downward movement of 2.64 inches, as opposed to no downward movement. The pair of constant support hangers at 6CR01006C, near the bottom of the riser, would also require replacement to accommodate the greater downward movement. The repair of lateral restraint 6CR01008R would decrease the loading at the turbine flange by directing thermal expansion away from the turbine.

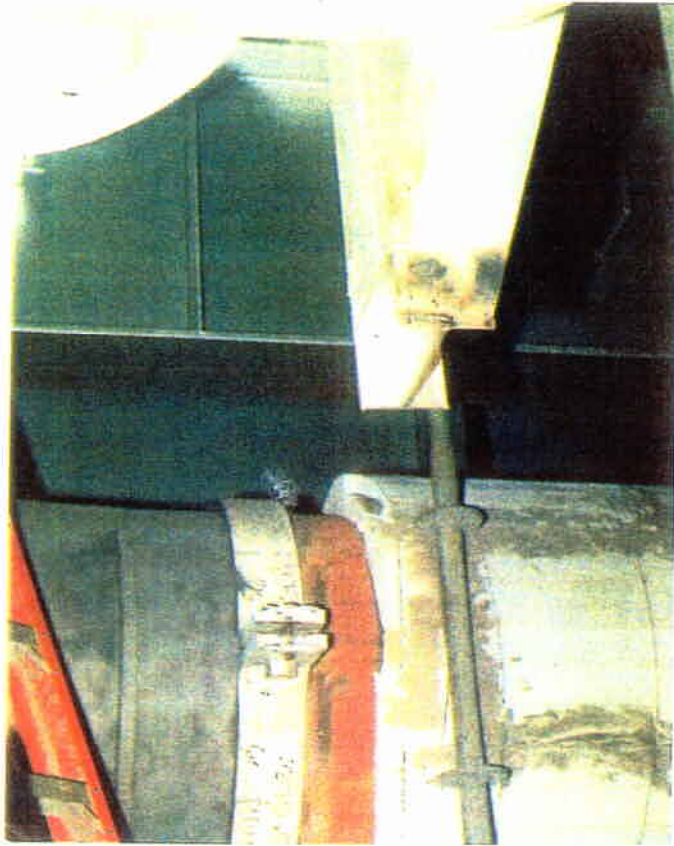
A failure analysis performed in 1990 attributed the failure primarily to cyclic bending stresses, with crack propagation occurring over several years. A system walkdown also revealed evidence of water hammer loading on the system, mainly in the form of damage to east/west lateral restraint 6CR01008R, Fig. 2.

The discussions with plant personnel also revealed that the west turbine flange connection had leaked and been replaced on three occasions since 1978. When the flange was unbolted, the turbine lead sprung out of position, mainly due to the absence of restraint 6CR01008R. The restraint had been designed to guide thermal piping movement away from the turbine to minimize turbine loading.

FIG. 2. VIEW OF DAMAGE TO LATERAL RESTRAINT 6CR01008R.

Cold system walkdowns were performed during the November, 1991 outage, before and after setting the new constant support hangers. Constant support hanger 6CR01006C is shown after installation in Fig. 3. Lateral restraint 6CR01008R was repaired and reinforced.

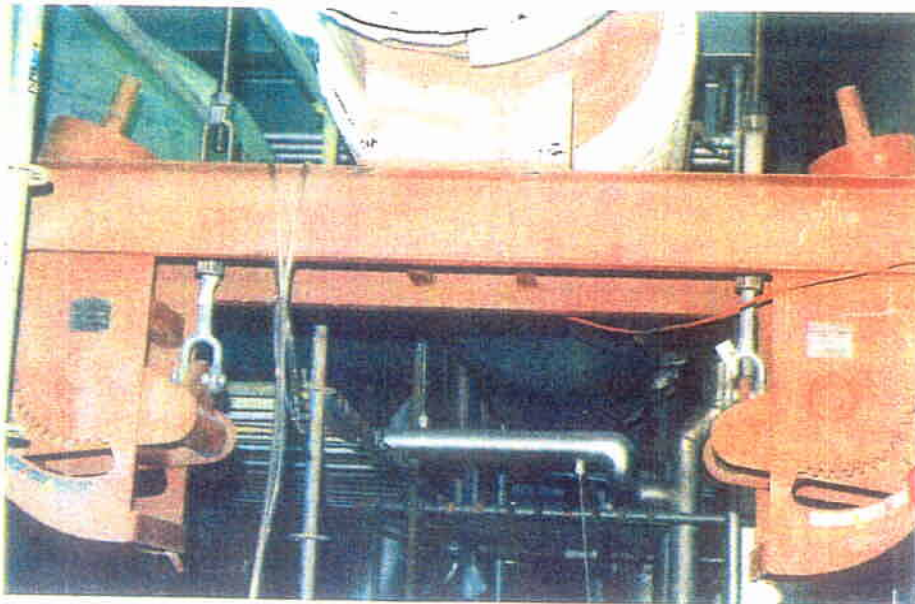
FIG. 3. VIEW OF NEW CONSTANT SUPPORT HANGER 6CR01006C.

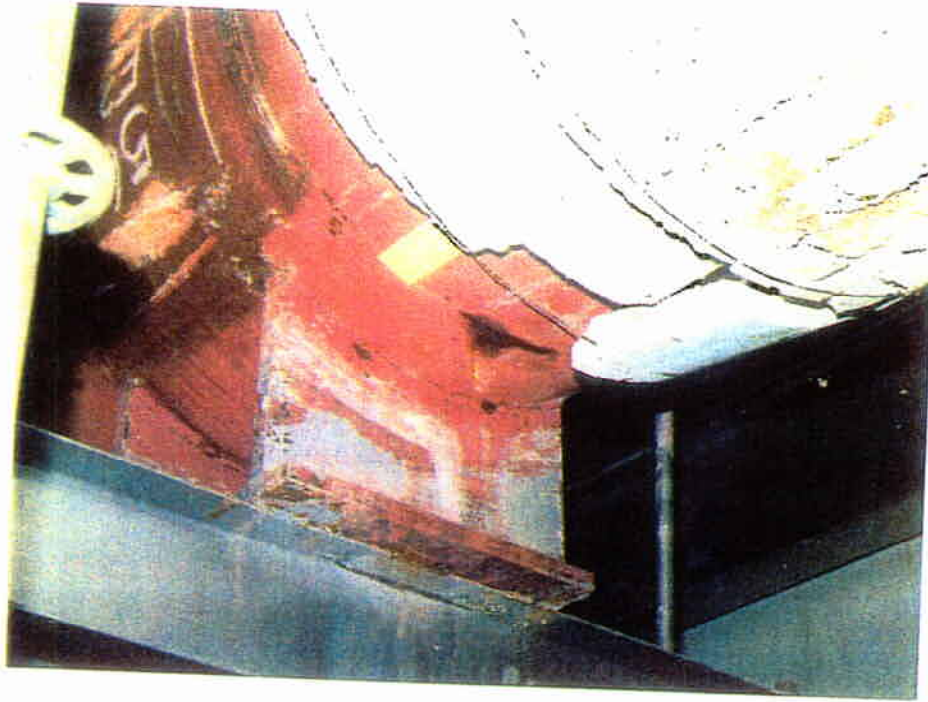
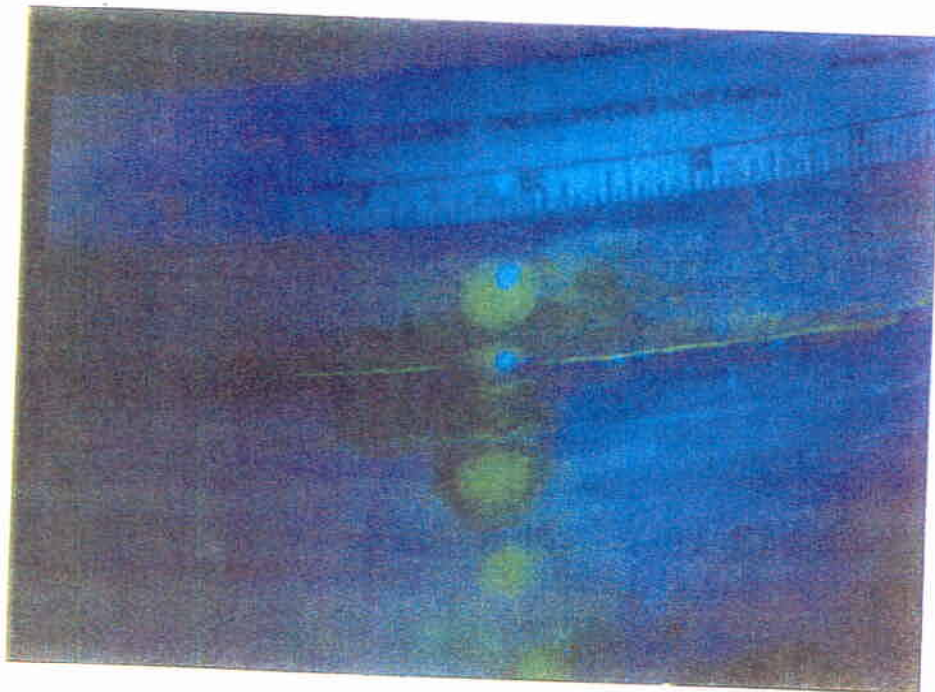
the system isometric sketch of Fig. 1, was located at the 6:00 o'clock position of the girth weld, Fig. 4. The lower photograph illustrates the crack as viewed during the wet fluorescent magnetic particle examination.

FIG. 4. VIEW OF THROUGH-WALL LEAK AT REPAIR LOCATION NO. 3.

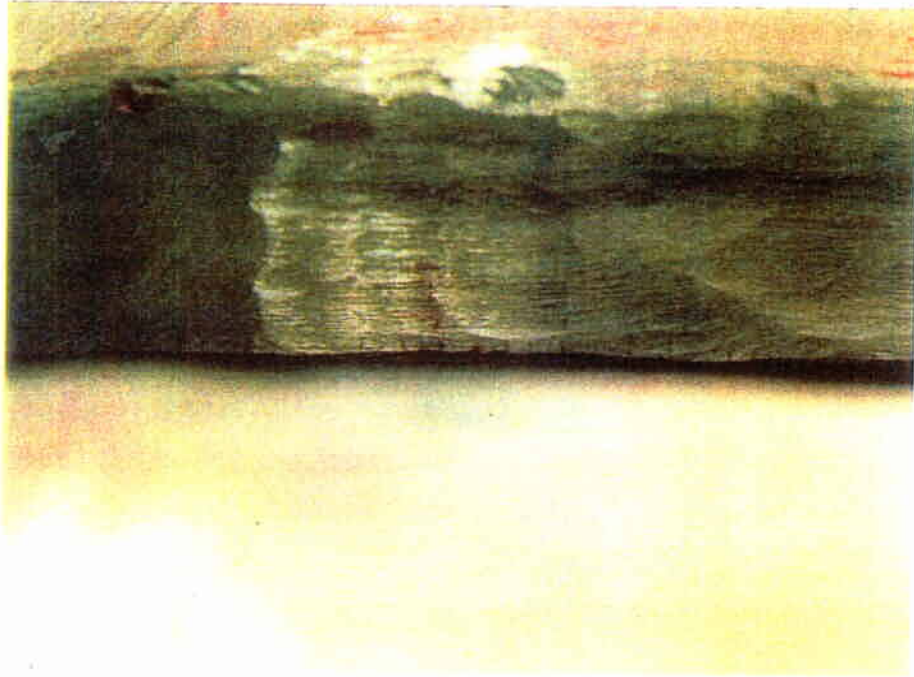
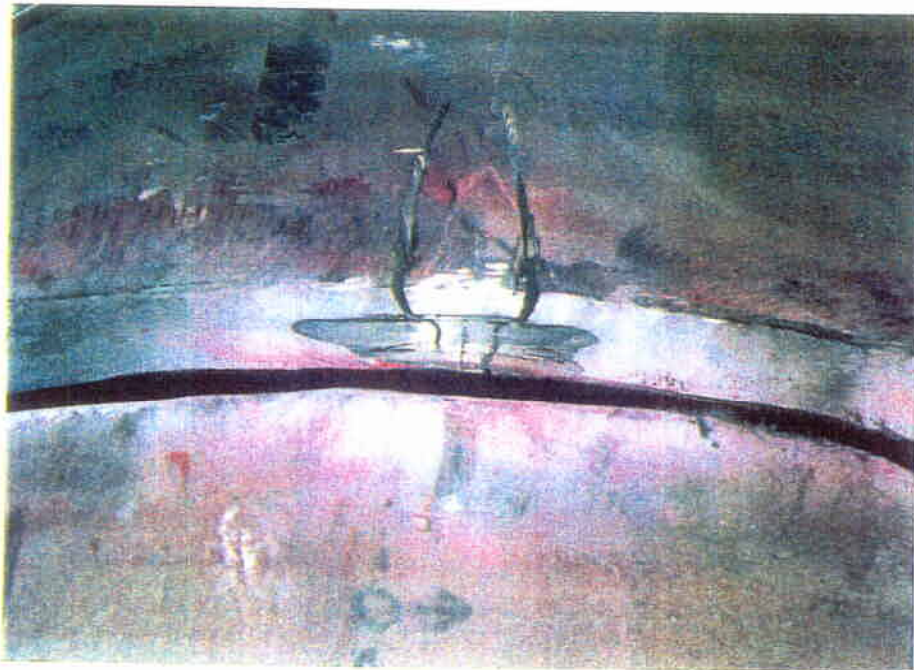
Sample No. 2 was removed transverse to the Cold Reheat circumferential weld at the top of the riser at the 12:00 o'clock pipe position, Fig. 5. Primary and secondary cracking transverse to the girth weld was evident along the inside pipe diameter. The cracks were aligned in the direction of the longitudinal seam. The cracking associated with the circumferential through-wall crack was not included with the sample No. 2 failure analysis.

FIG. 5. VIEWS OF TRANSVERSE CRACKS AT BOAT SAMPLE NO. 2.

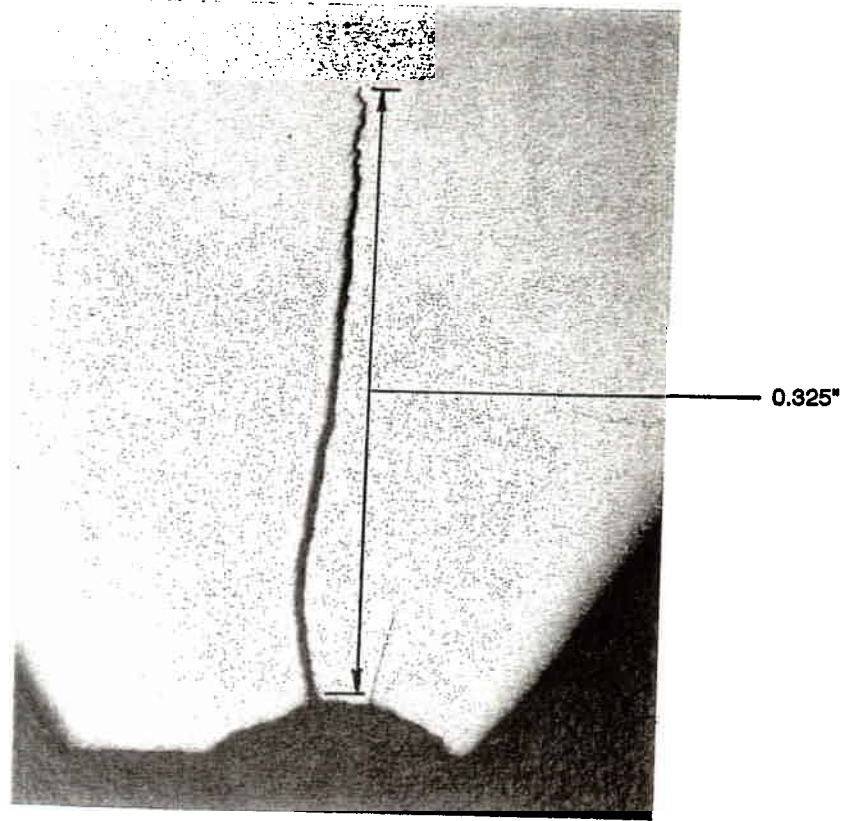
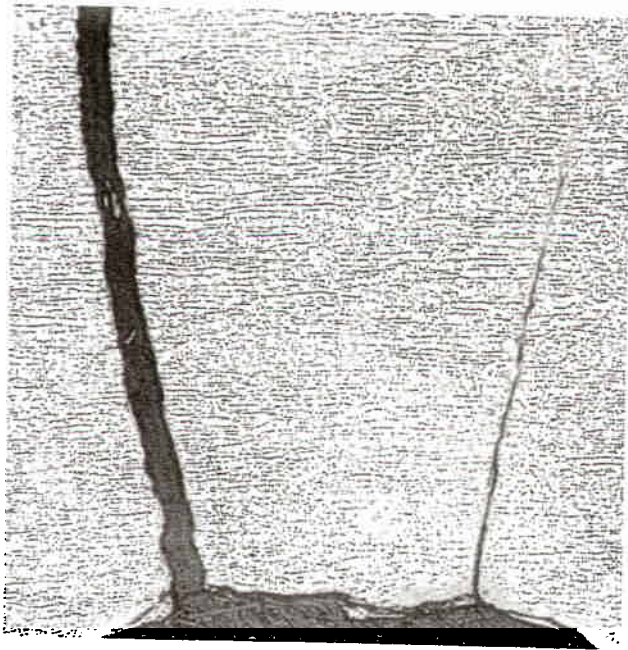
The primary transverse crack progressed from the inside diameter, Fig. 6. The crack measured 0.325 inches in depth. Secondary cracking was also evident, as shown in the lower left hand photograph. The secondary cracking appeared "tight" and was filled with scale. This condition is typical of slowly progressing cracks which are exposed to oxidizing conditions. The microstructure consisted primarily of ferrite with pearlite grains, typical of a carbon steel pipe material.

FIG. 6. PRIMARY AND SECONDARY CRACKING, LOCATION NO. 2.

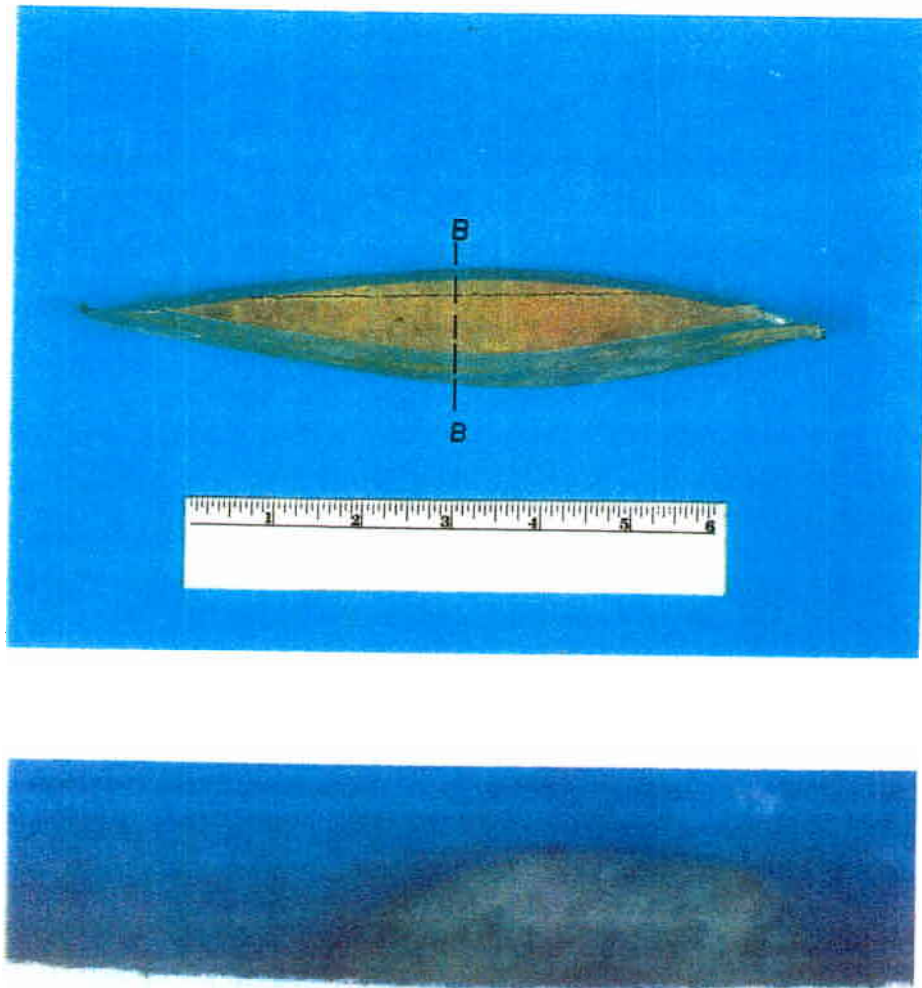
Sample No. 3 was removed from the through-wall crack at location No. 3. Circumferential cracking initiated from the inside diameter of the pipe at the 6:00 o'clock position. Views of sample No. 3 are provided in Fig. 7, before and after liquid penetrant examination. Fissuring transverse to the weld was evident throughout the internal diameter of the sample.

FIG. 7. SAMPLE NO. 3 BEFORE AND AFTER LIQUID PENETRANT EXAMINATION.

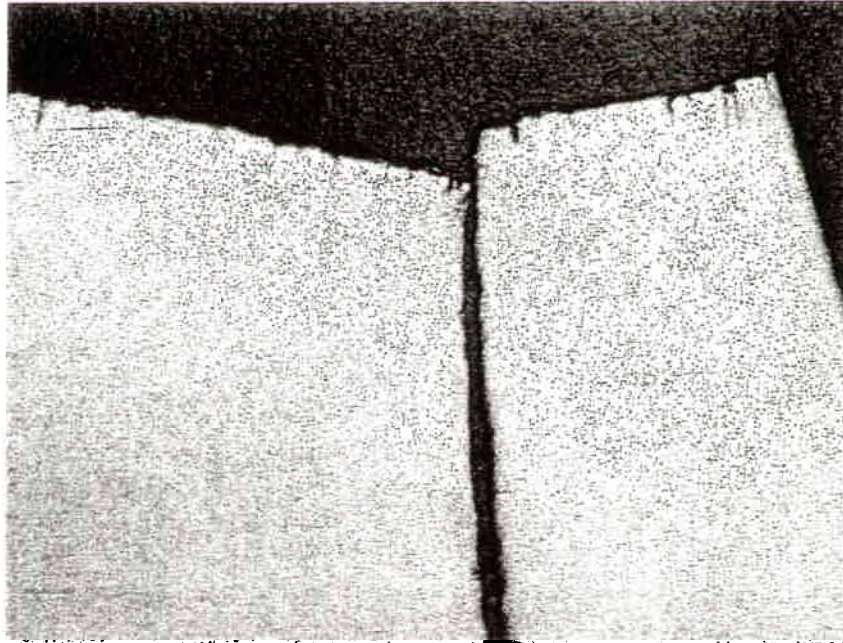
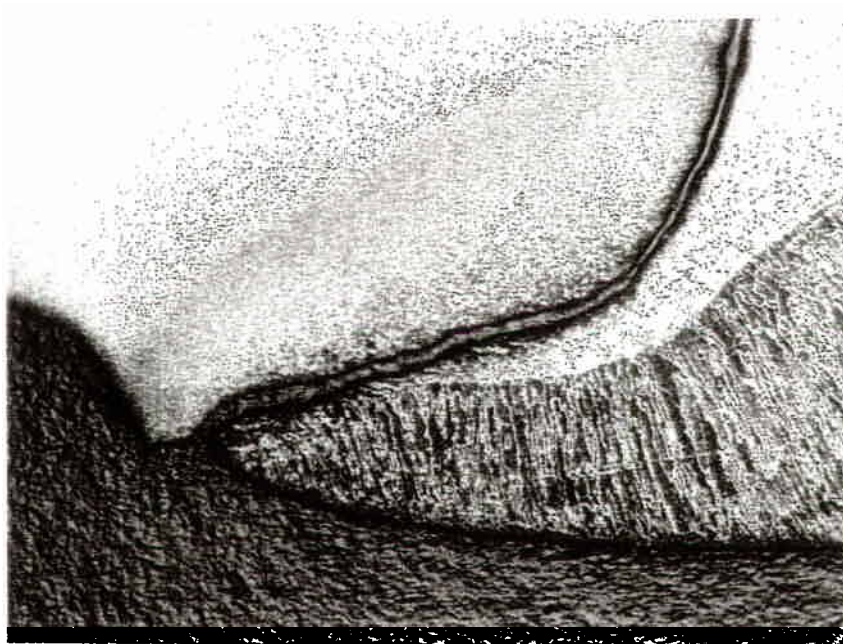
A cross section of the through-wall crack is shown in Fig. 8. The photomicrographs illustrate the crack progression from the inside base metal, into the heat-affected zone, and then to the weld fusion line. The linear transgranular progression is typical of fatigue cracking. Secondary cracks were evident along the internal diameter surfaces and along the primary crack. Laboratory measurements of scale thickness confirmed the presence of heavy scale at the initiation point and lesser scale near the final stages of crack progression.

Contributing to the initiation of the failures were "notches", or stress risers on the inside diameter of the pipe, due to pipe beveling for the original fabrication fit-up. This was most evident at failure locations Nos. 3 and 4, Figs. 8 and 10, respectively. Cracking initiated at the notch and progressed in a straight path through the base metal. This is typical of fatigue cracking, which is highly sensitive to notch conditions. Nevertheless, even in the absence of the notches, the fatigue related cracking could eventually have occurred at essentially the same locations. Although through-wall piping failures more commonly progress from the outside pipe diameter, particularly when sustained stresses are the cause, cracking initiated at the inside diameter at all four locations.

FIG. 8. PHOTOMICROGRAPHS OF SUBSEGMENT CUT AT CROSS SECTION "B-B".

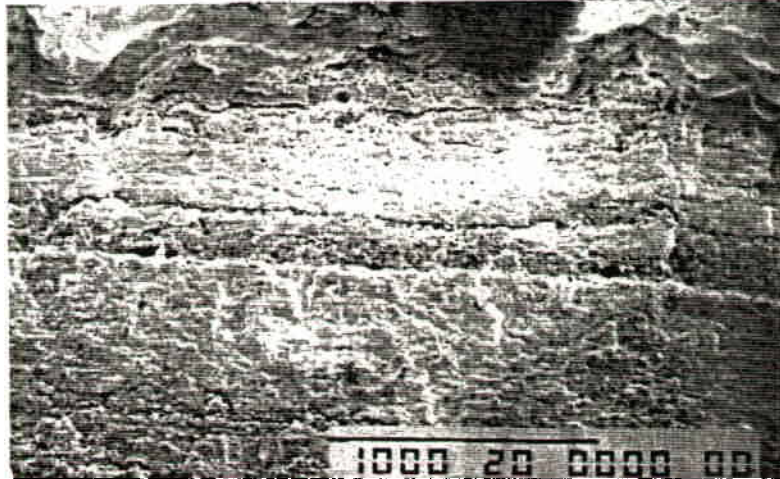
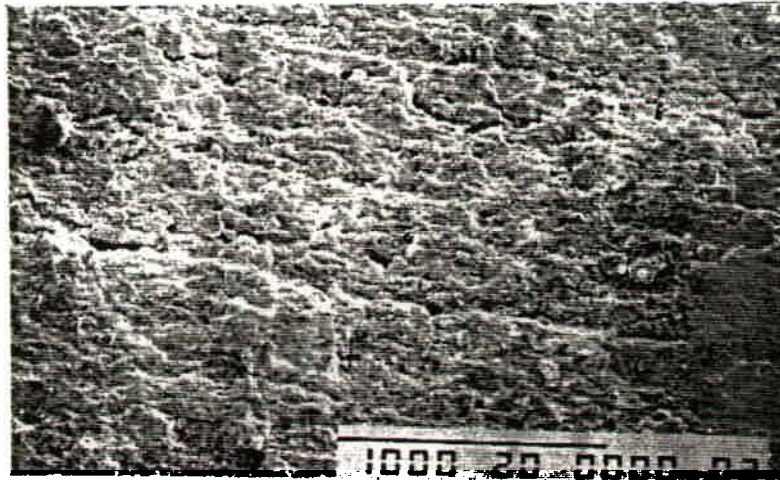
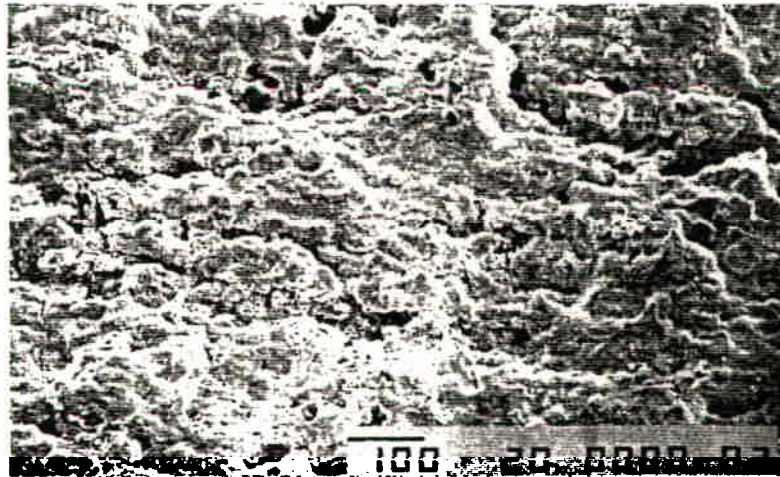
After metallurgical evaluation, the remaining portion of sample No. 3 was separated to examine the fracture surface using Scanning Electron Microscopy (SEM). Fractographs of the examined areas are shown in Fig. 9. Beach marks are apparent, which are characteristic of fatigue cracking stages. Due to heavy scaling, fatigue striations could not be resolved. This is not uncommon when materials are exposed to thermal fatigue conditions.

FIG. 9. SCANNING ELECTRON MICROGRAPHS (SEM) OF SAMPLE NO. 3 AFTER SEPARATION.
