Presented at the EPRI International Conference on Welding and Repair Technology for Fossil Power Plants  
March 23 through 25, 1994 in Williamsburg, Virginia

## **CONDITION ASSESSMENT AND REPAIR WELDING OF HIGH TEMPERATURE HEADERS**

**Matthew Dowling  
Thielsch Engineering, Inc.  
195 Frances Avenue  
Cranston, Rhode Island 02910**

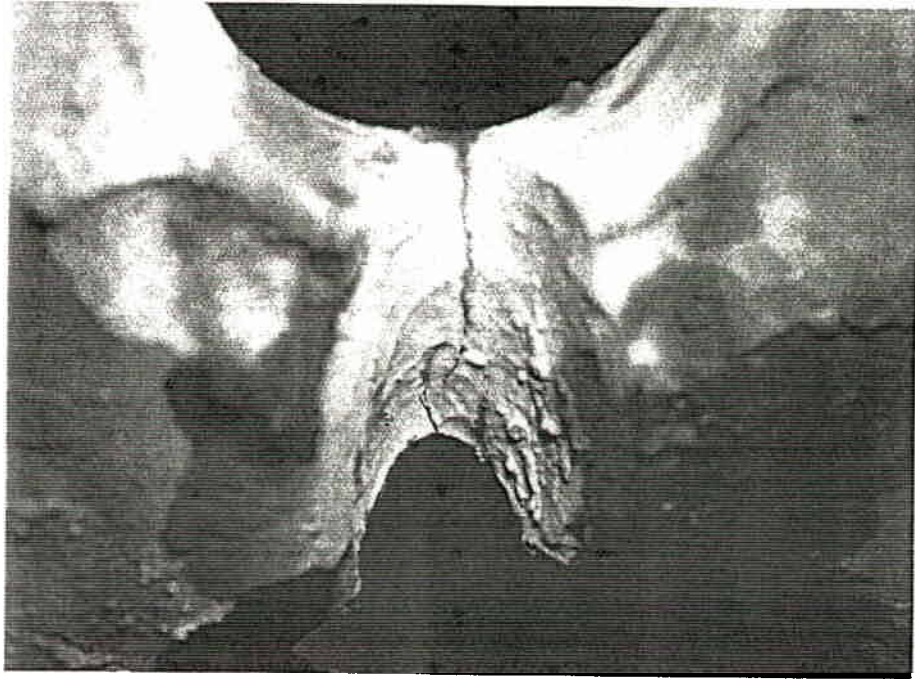
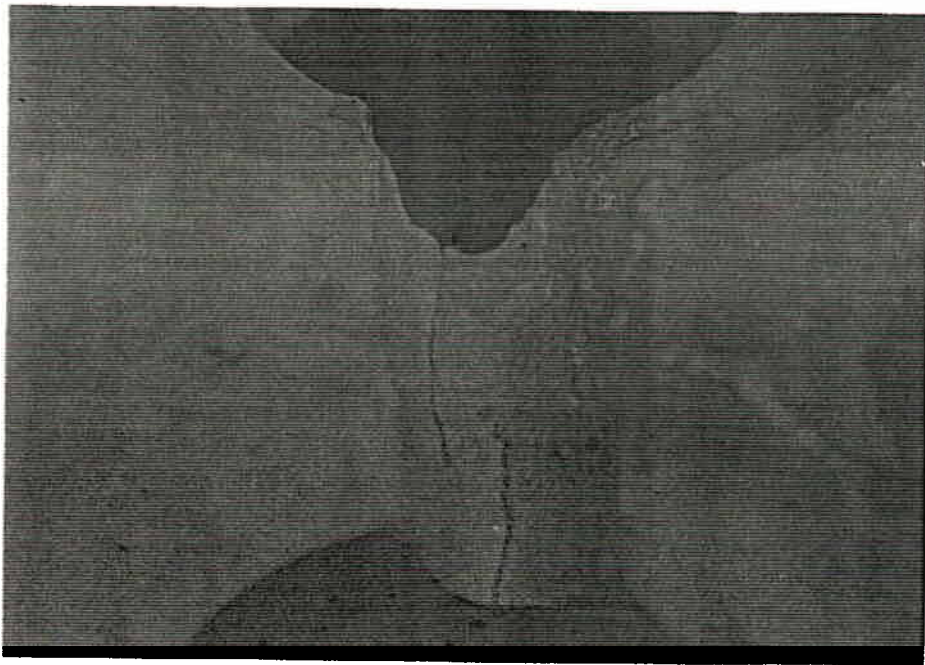
One of the most highly stressed portions of these headers is the ligament area between the two bore holes. These ligament areas are highly susceptible to hoop stresses, thermal fatigue, creep and ultimately cracking.

As part of a condition assessment program, an eastern utility identified ligament cracking in their reheat outlet header in 1985. At that time, six of the severe crack locations were repair welded. The details of the procedure utilized during that repair were not available; however, minimum preheat was applied. A postweld stress relief heat treatment was not performed. In 1990, a reinspection of this header revealed additional cracks and re-cracking of the repair welded areas. TEI was contracted to evaluate the existing condition and provide repair recommendations.

Figure 1. Typical cracking configuration.

The first phase of the actual repair involved removal of the tubes from the header which were in the way of the repair locations. Second, several samples were removed from the ligament area for further metallurgical evaluation. The analysis of these samples will be discussed later in the paper. Next the area selected for repair were air arc gouged to remove the cracking and prepare the weld joint. This crack removal was performed very carefully to determine the actual crack depth and crack configuration. A photograph during this process is provided in Fig. 1. As noted, the crack depths were very carefully monitored. It was determined that the ultrasonic inspection procedure utilized accurately determined the crack depth within 10%. The final weld joint preparation involved an open root such that a full penetration weld could be achieved.

Prior to the repair welding, the areas were preheated utilizing resistance pads to the required temperature. This preheat temperature was very closely monitored with the use of Tempilstiks and was maintained during the entire repair welding process. The repair was performed utilizing the shielded metal arc welding process. An initial attempt at the root pass utilizing Tungsten inert gas welding was made; however, this was not successful as it was impossible to clean the ID surface sufficiently. The repair welding was

performed utilizing a proprietary specialized technique which will reduce the residual welding stresses and result in a beneficial microstructure. This involves the use of a high preheat in conjunction with a stringer bead buttering technique.

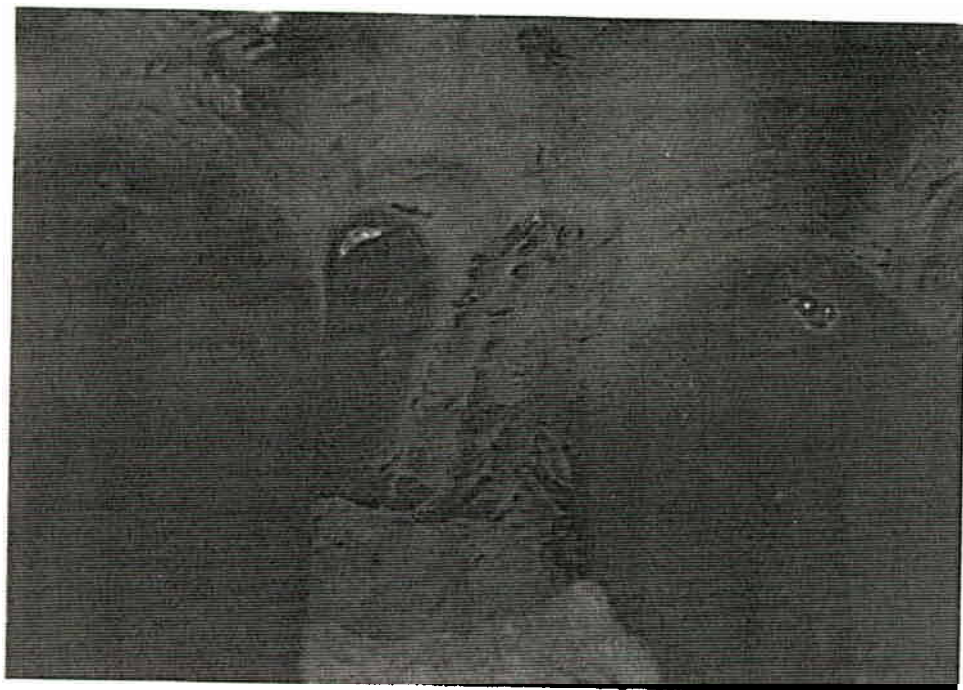
Figure 2. Typical final weld configuration.

Following the completion of the repair of the ligaments, the tubes were reinserted into the header. A photograph of a typical final weld configuration is provided in Fig. 2. Following the installation of the tube stub, the entire area was stress relieved in accordance with Section I of the ASME Code. After the completion of the stress relief heat treatment, all the repair areas were subjected to detailed nondestructive examination. There were no discrepancies noted during these evaluations.

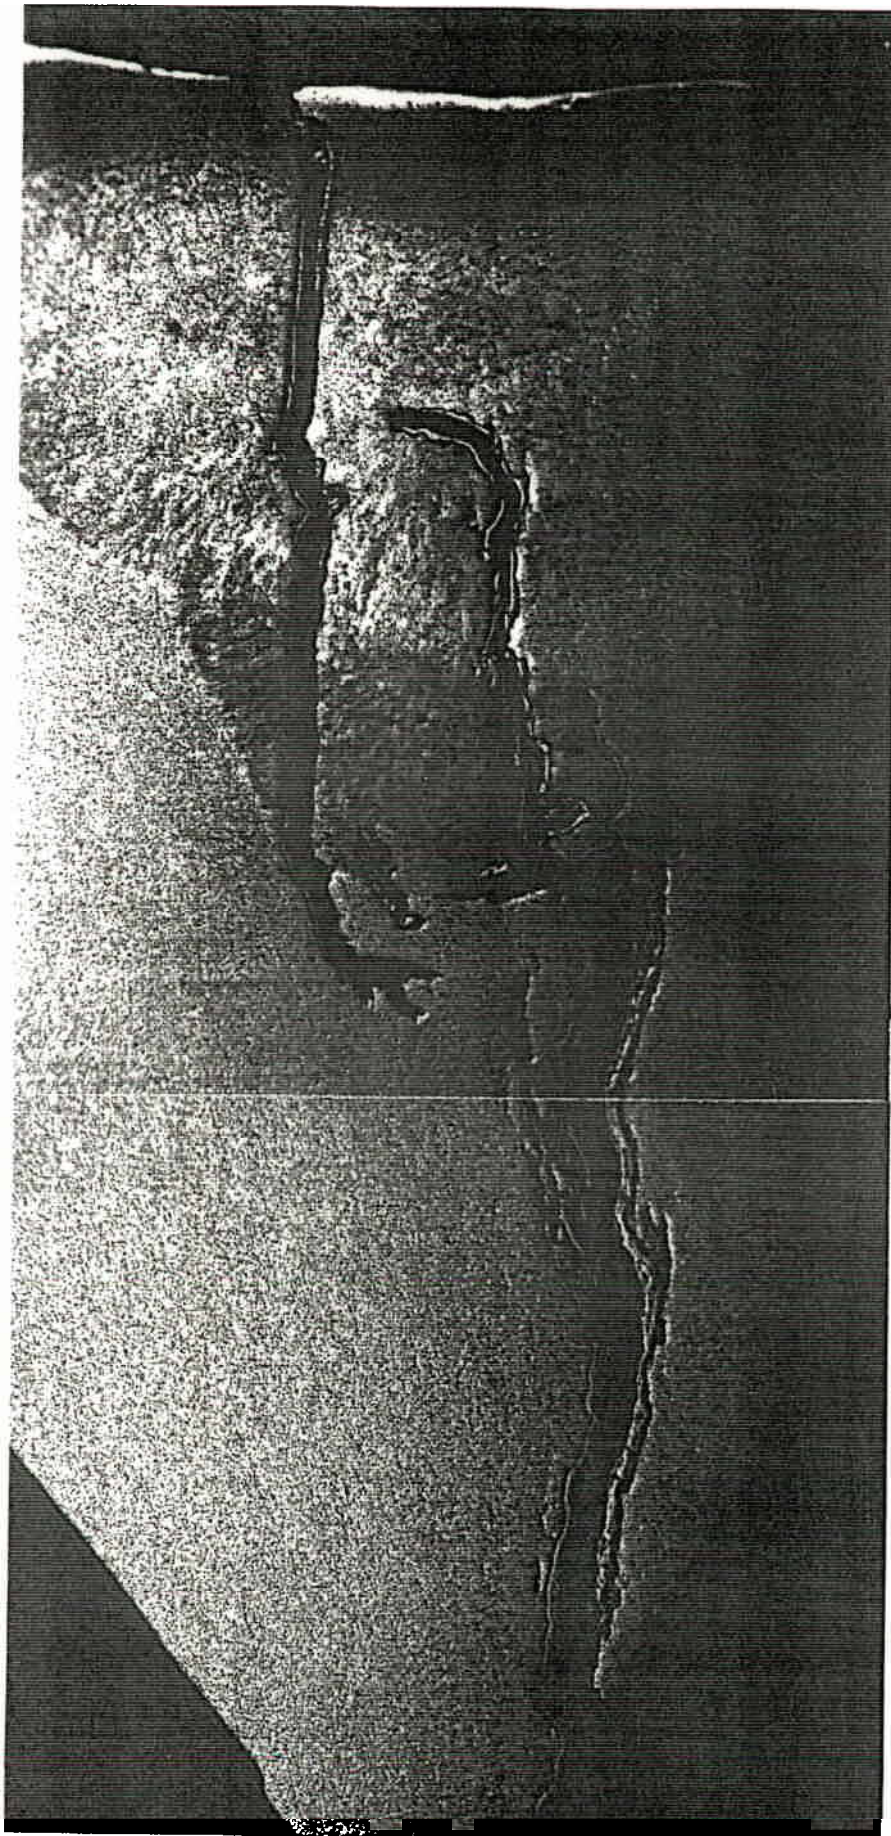
Samples which were removed from the header were subjected to a detailed metallurgical evaluation. This included material identification, determination of the effects of the metallurgical changes that tend to occur gradually at elevated temperatures in a header and evaluation of the previous repair welds. Material identification was performed prior to the repair welding such that the proper electrode could be selected. The existing condition evaluation was performed to determine if significant creep damage had occurred which would have altered the scope of repair. This evaluation determined that there was not extensive creep damage and the header was readily repair welded. Evaluation of the previous repair revealed several interesting conditions. A photograph of the cross section is provided in Fig. 3. As is evidenced, the previous repair did not completely remove the existing cracking. In addition, the re-cracking of the repair weld in a relatively short period of time indicated that a repair was performed with insufficient preheat and no post weld stress relief. This information was valuable when developing the repair program for the current repair.

Figure 3. View of sample.
