BY HELMUT THIELSCH AND  
FLORENCE CONE

# EQUIPMENT FAILURES

*Mills need to use predictive and preventive maintenance programs*

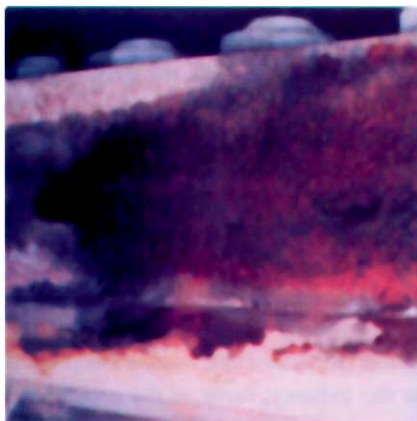
**Fig. 1 (above):** Corrosion product build up at the head to shell surface.

From 1985 to 1990, there were eight known cases of cracks appearing in the heads of Yankee dryers. In all of these cases, a corrosion product buildup at the head-to-shell interface preceded the cracking (see Fig. 1).

The buildup of this corrosion product gradually reduces the contact between the head and the shell flange sections.

The loss of uniform contact between the head and the shell flanges, in turn, increases the bolt clamping forces. This creates bending of the head section and high tensile stresses in the bolt hole circle and/or spigot fit area. Over time, these stresses may produce mechanical fatigue cracking in the head or shell.

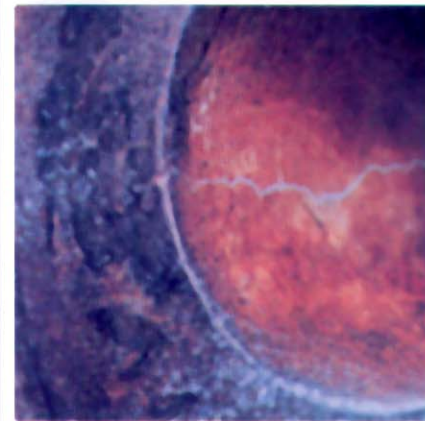
**Fig. 2 (above right):** Cracking in bolt hole circle detected by borescopic examination.

If mills use these inspection techniques on a regular basis, they will detect incipient or progressive cracking. The mills can verify the cracking by borescopic examination (see Figure 2). In addition, they can use ultrasonic examination to size and detect cracking.

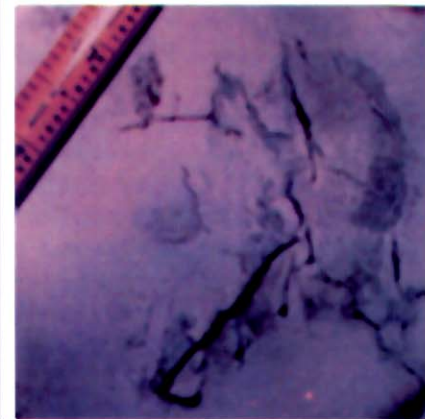
**Fig. 3 (right):** Casting shrinkage in dryer roll head.

Because the purpose of these inspections is to detect dryer rolls in danger of catastrophic failure, mills should perform them on a regular basis. Extreme care should be taken, however, in interpreting the results of these inspections as dryer rolls represent cast iron products that may contain a large number of rather alarming looking indications, which are, in fact, inconsequential. For instance, the indication shown in Fig. 3 represents a casting shrinkage defect that has not progressed since installation.

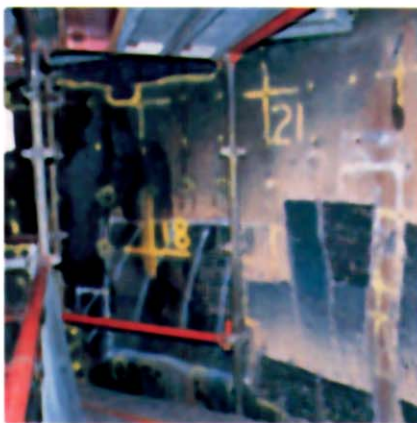
*Fig. 4 (below): Typical appearance of periodic weld overlays made in a continuous digester.*

At some mills, employees apply weld overlays in stages by building up the wall thickness in the most severely corroded area by approximately 1/4 inch to 3/8 inch during each outage stage (see Fig. 4). During such weld buildup stages, very careful monitoring of the quality of the wall thickness (i.e., complete weld fusion) is essential. Mill employees can then apply additional weld overlay thickness levels during convenient plant outages at 6-to-12 month intervals until the original design wall thickness is restored.

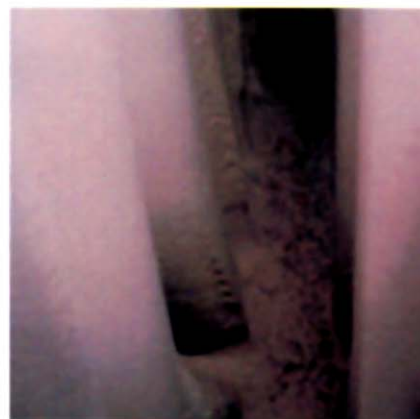
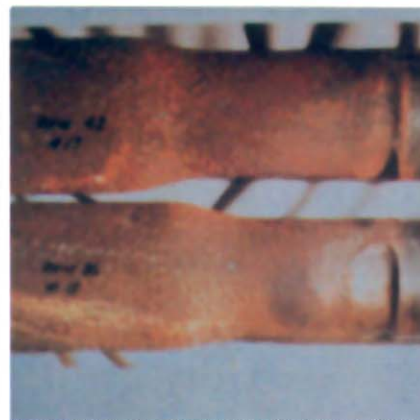
*Fig. 5 (right and below right): Examples of thinning in generating tubes.*

Another area of concern in recovery boilers is tube thinning. This thinning or metal wastage along the surface of the tube is typical of erosion which abrades the surface of the tube uniformly and smoothly (see Fig. 5). It is significantly different from corrosion that tends to result in nonuniform deterioration with preferential attack along the grain boundaries. The mechanism of erosion is also supported by the localized condition representing one side of the tube circumference.

There is some disagreement as to the cause of tube thinning. This erosion is

likely to represent a combination of gas flow through the recovery boiler in conjunction with eddy currents caused by soot blowing. The erosion occurs primarily in the tube immediately above the drum surface as a result of the gas flow over the drum surface.
