Presented at Power Gen '90
Orlando, Florida, December 1990

CAPACITIVE CREEP STRAIN MEASUREMENTS FOR PREDICTIVE LIFE DETERMINATIONS

by
Helmut Thielsch, Nancy Knarr, and Caroline Burdick*

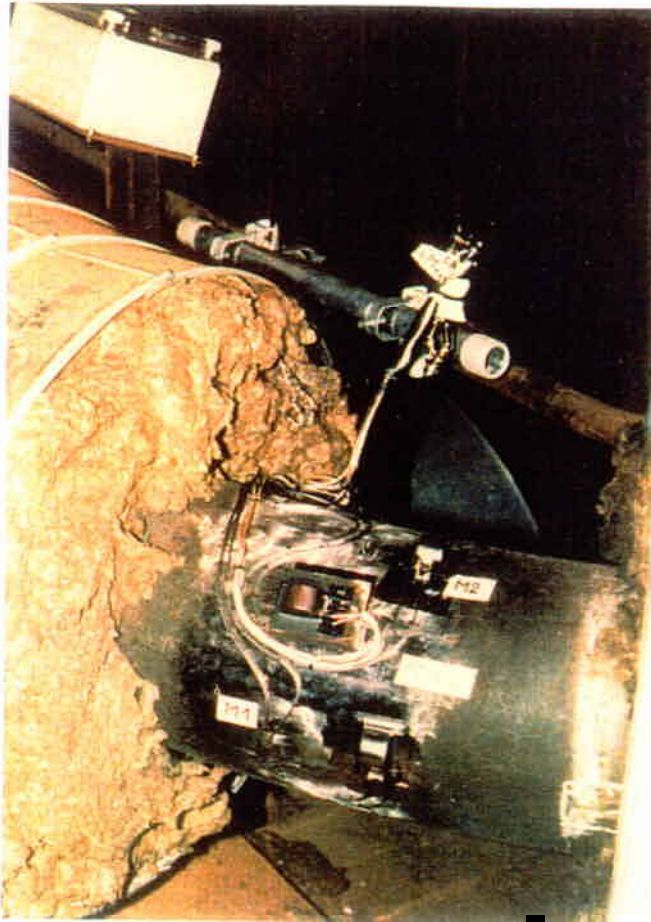
Fig. 11. Typical installation of capacitive strain gages on surface of main steam pipe.

The locations for the actual high temperature creep measurements are then selected and the pipe surface is prepared for the attachment of the capacitive strain gages. Figs. 11 and 12 illustrate typical installations of capacitive strain gages. Prior to the replacement of the insulation, protective covers are spot welded to the pipe surface to insure that the capacitive strain gages remain functional for periods of many years and thus do not require repair or replacement during normal plant operations.

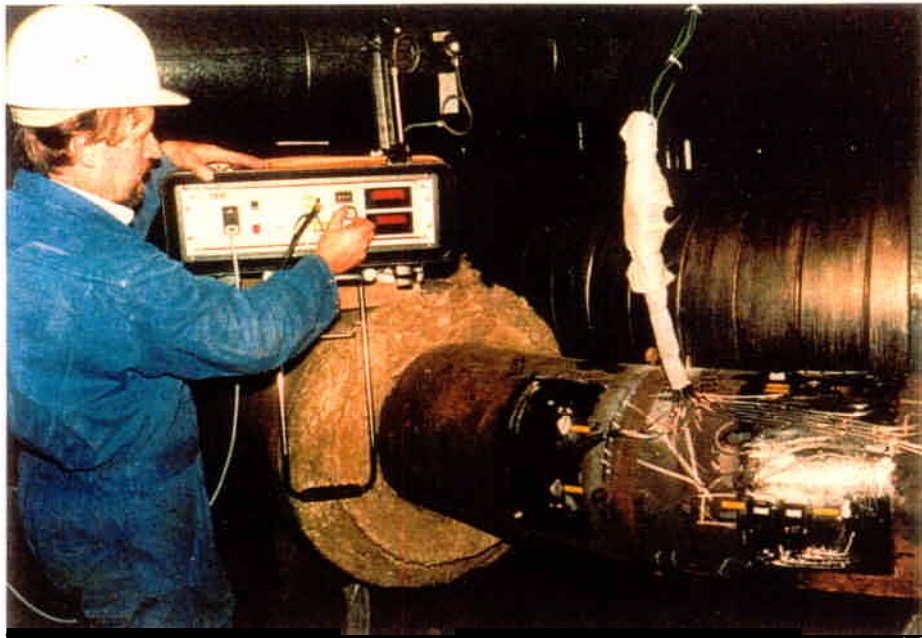
Fig. 13. Calibration and baseline data recorded prior to re-insulation and piping system start-up.

Baseline and calibration readings are then taken of the capacitive strain gages while the pipe is cold and before the insulation is re-applied, Fig. 13. The insulation is then re-applied and the piping systems are returned to service.
