TECHNICAL BULLETIN

January 2010

SUBJECT: Boiler Tubing - Corrosion Fatigue Failures

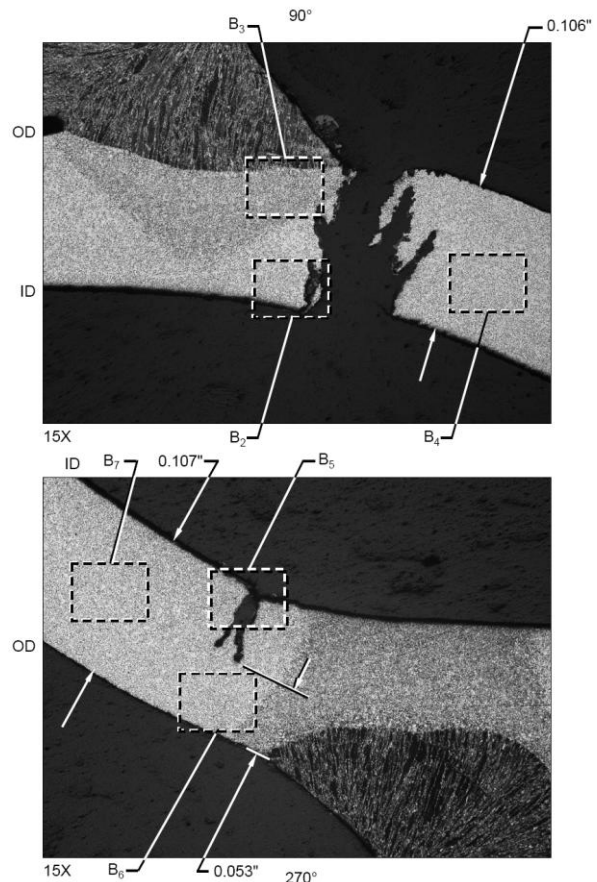
Since 1999, Thielsch Engineering has been involved in the failure analysis and inspection of more than five (5) catastrophic failures of water circuit tubing resulting from corrosion fatigue. Three (3) of these instances had resulted in significant injury and death to plant and contractor personnel. In the preceding twenty years of business, Thielsch Engineering had no similar catastrophic assignments. This increase is directly related to the power industries trend towards more cyclic and peaking operation of their aging boilers to meet new market demands. The thermal swings associated with the increased cyclic/peaking operation are the primary driver for the fatigue element of "corrosion fatigue" failures.

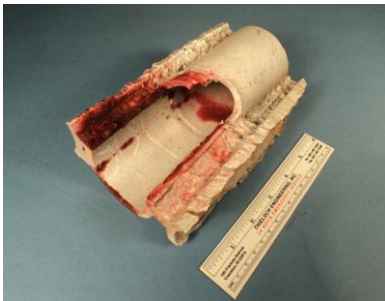
Significant efforts have been expended by boiler OEM's and engineering firms to develop design modifications and inspection technologies to first eliminate the potential and second to identify the incipient conditions prior to failure.

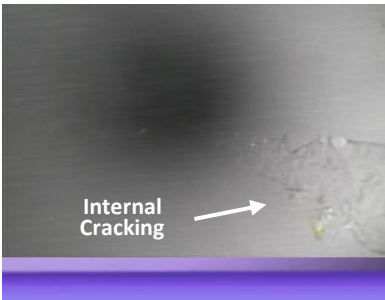
What the industries have found is that there is no easy or expedient way to resolve corrosion fatigue cracking within water circuit tubing. The most commonly recognized methods involve significant modifications to the boiler structure strong backs, door openings, and corner restraints. On the inspection side, costly destructive work is required to gain access to the areas for inspection, i.e. cutting away the boiler casings to perform specialized ultrasonic examinations or cutting "pigeon holes" in the tubing to conduct internal borescopic inspections.
